Foundation Design, P.C.

Reference: North Road Townhouses
156 Stewart Place, Canandaigua, New York
Geotechnical Evaluation, 5552.0

This report summarizes our Geotechnical Evaluation for the referenced project. We understand that the project consists of developing a 27.5-acre parcel into a residential townhouse subdivision. A total of 164 residential units will be constructed, contained in two, four and six unit buildings. The buildings will consist of two to three story, wood framed structures, possibly with basements. New roadways, parking areas, underground utility lines, and stormwater infrastructure will be developed. We base this evaluation on a review of U.S.G.S. topographic and geologic mapping, conceptual site plans, test pit/macro core exploration, laboratory test results, and consultation with the design team. Chrisantha, Inc. retained Foundation Design, P.C. to provide the services outlined in our November 22, 2023, *Geotechnical Services Proposal, P5538.0*. We intend the conclusions and recommendations outlined in this report exclusively for use in the design and construction of this project.

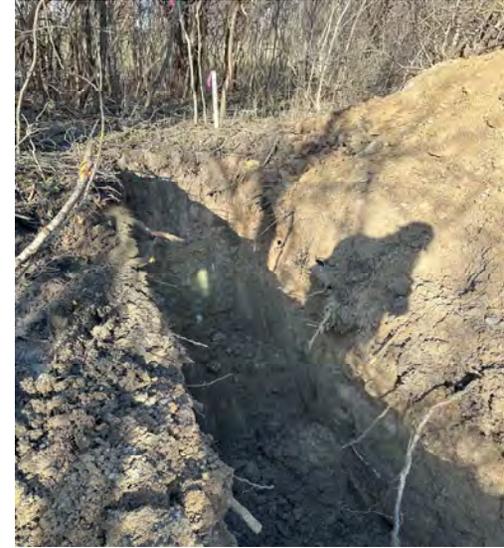
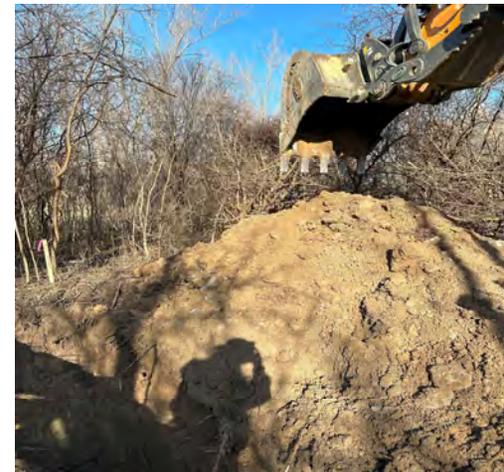
Depth Below Surface	Sample Number	Depth of Sample	Soil and Rock Classifications
			Remarks
			TOPSOIL
2			1'6" Soft brown saturated CLAY
4			2'9" Dense gray-brown wet SILT, some gravel, some sand, trace clay, numerous cobbles
6			(Boulders at 4'5") (Very dense at 5'2")
8			7'0" Test Pit Terminated at 7'0" (On Boulder)
10			
12

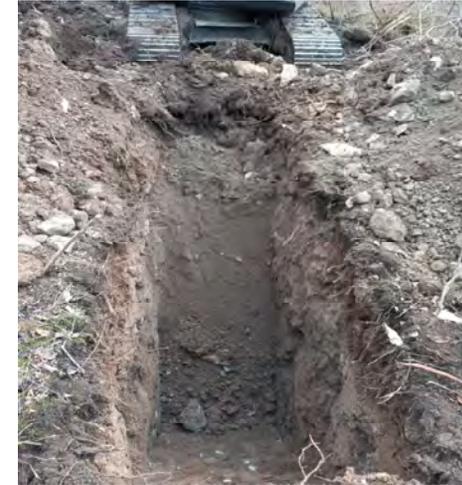
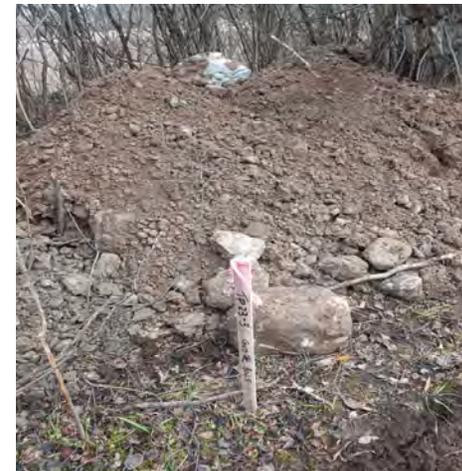
Depth Below Surface	Sample Number	Depth of Sample	Soil and Rock Classifications Remarks
2			TOPSOIL
			1'0"
4			Firm red-brown moist-wet silt, trace gravel
			2'0"
6			Dense tan-brown wet to saturated SILT, some sand, some gravel, trace to little clay, rootlets noted
			Numerous cobbles noted at 2' to 4'
8			Few boulders at 4'4"
			Very dense
10			Very dense grey wet SILT, some gravel, little to some sand, little clay
			5'0"
12			Medium red-brown moist CLAY, little sand, little gravel
			6'0"
12			Very dense grey wet SILT, some gravel, some sand, little clay
			7'0"
12			Test Pit Terminated at 9'4"
			9'4"

1. Sides vertical upon completion.
2. Dry on completion.
3. Staked location and elevation provided by Costich Engineering.

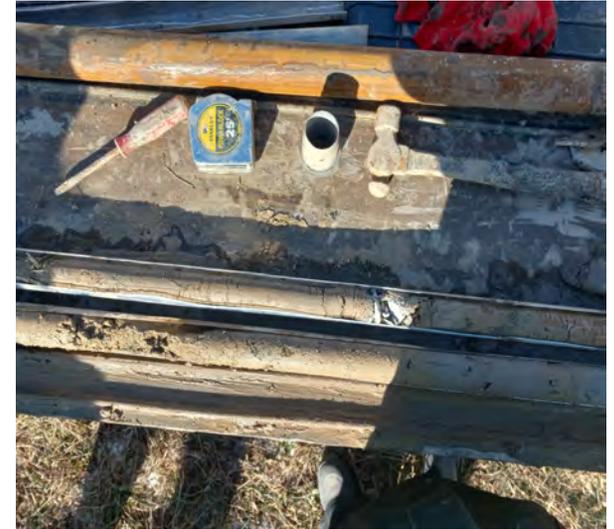
Depth Below Surface	Sample Number	Depth of Sample	Soil and Rock Classifications
			Remarks
2			TOPSOIL <hr/> Compact brown moist to wet SILT, some gravel, little to some sand 0'6"
4			
6	S-1	4'-5'	Medium brown moist to wet CLAY, some silt, little gravel PP: 3.0 tons/f ² 5'0"
8			Very dense gray-brown wet SILT, some gravel, little to some sand, trace to little clay 6'9"
10			
12			Terminated at 11'8" (On Possible Cobble/Boulder) 11'8"

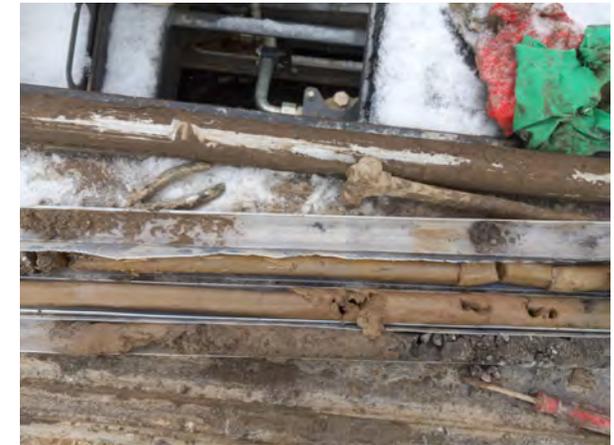
- Notes:
1. Sides vertical upon completion.
 2. Water noted at 6'.
 3. Staked location and elevation provided by Costich Engineering, Land Surveying & Landscape Architecture, D.P.C.

Depth Below Surface	Sample Number	Depth of Sample	Soil and Rock Classifications Remarks
2			TOPSOIL Stiff brown-red wet CLAY, little silt 0'5"
4			
6			6'0"
8			Dense brown wet to saturated SILT, some gravel, some sand, trace clay 7'6"
10			Very dense gray damp to moist SILT, some gravel, little to some sand, trace clay
12			12'0" Test Pit Terminated at 12'0"

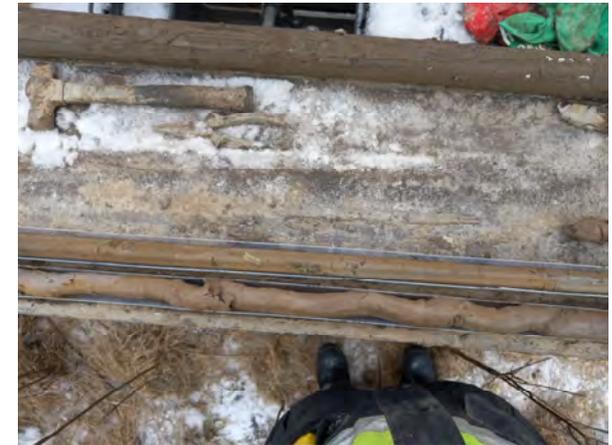
1. Sides vertical upon completion.
2. Water noted at 5'.
3. Staked location and elevation provided by Costich Engineering, Land Surveying & Landscape Architecture, D.P.C.

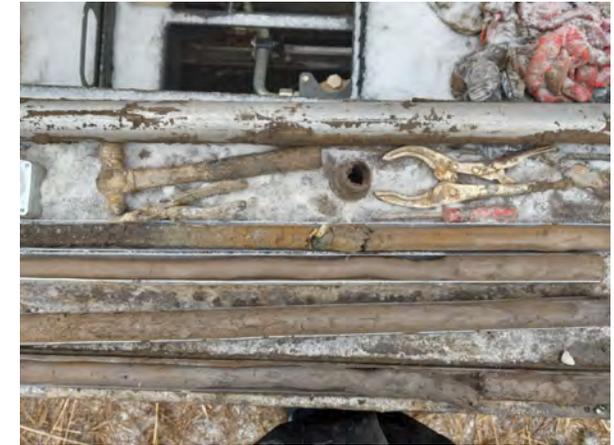
1. Sides vertical upon completion.
2. Dry on completion.
3. Staked location and elevation provided by Costich Engineering, Land Surveying & Landscape Architecture, D.P.C.

Depth Below Surface	Sample Number	Depth of Sample	Soil and Rock Classifications Remarks
2			TOPSOIL <hr/> Firm brown-gray saturated SILT, some clay, organics noted 1'0" 2'0"
4			Stiff brown-gray-red-wet CLAY, little silt <hr/> 5'0"
6			Stiff brown-gray wet CLAY, trace silt <hr/> PP: 4.0 tons/f ²
8			PP: 1.25 tons/f ²
10	S-1	9'-10'	Soft brown-gray wet CLAY, trace to little silt 9'0"
12

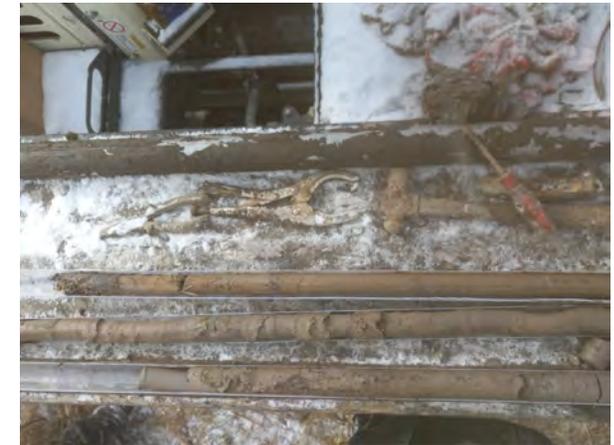
1. Sides vertical upon completion.
2. Dry on completion.
3. Staked location and elevation provided by Costich Engineering, Land Surveying & Landscape Architecture, D.P.C.

Depth Below Surface	Sample Number	Depth of Sample	Soil and Rock Classifications Remarks
2			TOPSOIL Stiff brown-gray-pale red moist to wet CLAY, little to some silt, trace gravel PP: 3.25 tons/f ² 0'6"
4			4'0"
6			Stiff brown-gray moist to wet CLAY, trace to little silt
8	S-1	7'-8'	PP: 4.25 tons/f ² 8'0"
10			Compact brown-gray wet SILT, some clay, little to some gravel 10'0"
12			Very dense brown-gray moist SILT, some gravel, little sand, trace to little clay 12'0" Terminated at 12'0"

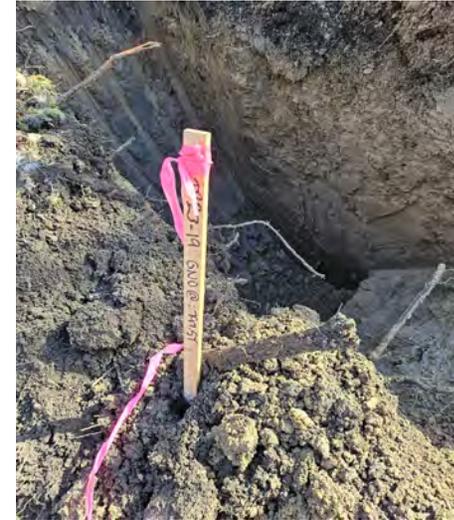
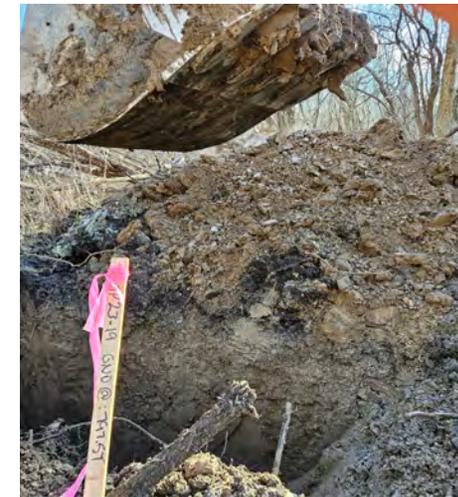
Depth Below Surface	Sample Number	Depth of Sample	Soil and Rock Classifications Remarks
			TOPSOIL (standing water at surface)
2			Soft tan-brown moist CLAY, some silt, trace sand, trace gravel 1'2"
4			
6			(Wet at 6'0")
8			
10			Firm brown wet SILT, some sand, little gravel, trace clay 9'6"
12			Test Pit Terminated at 11'0" 11'0"

1. Sides vertical upon completion.
2. Dry on completion.
3. Staked location and elevation provided by Costich Engineering, Land Surveying & Landscape Architecture, D.P.C.

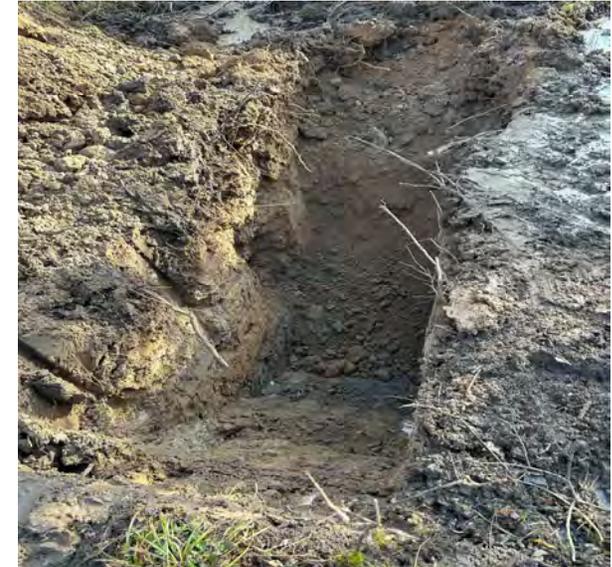
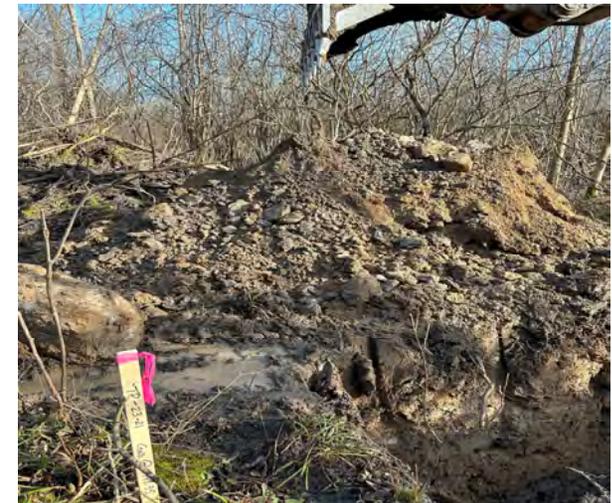
Depth Below Surface	Sample Number	Depth of Sample	Soil and Rock Classifications
			Remarks
			TOPSOIL (standing water at surface)
2			1'0" Very dense brown saturated SAND, some silt, little to some gravel, trace clay
4			4'2" (Boulder noted) Very dense gray-brown wet SILT, some sand, some gravel, trace clay, numerous cobbles, numerous boulders
6			
8			7'3" Test Pit Terminated at 7'3"
10			
12

1. Sides vertical upon completion.
2. Dry on completion (standing water at surface)
3. Staked location and elevation provided by Costich Engineering, Land Surveying & Landscape Architecture, D.P.C.

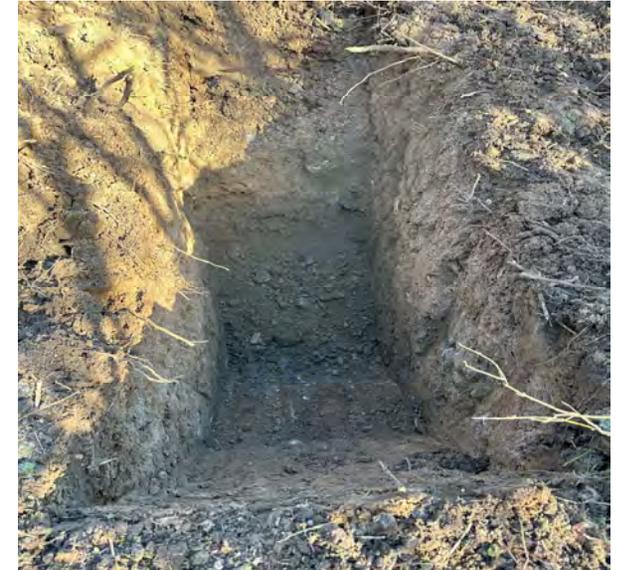
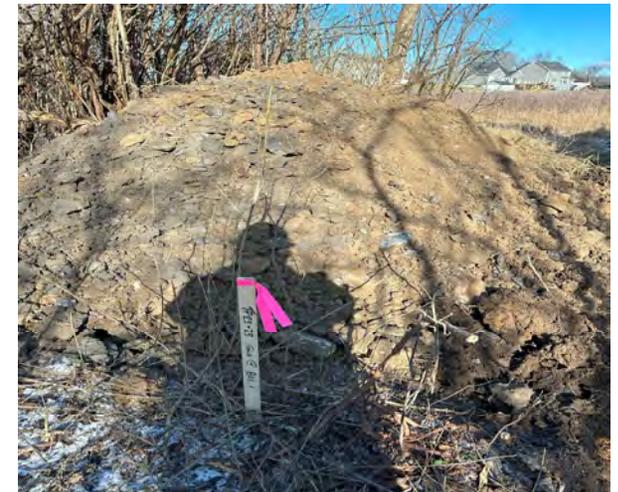
Depth Below Surface	Sample Number	Depth of Sample	Soil and Rock Classifications	
			Remarks	
			TOPSOIL	
2				1'0" Medium brown-gray wet CLAY, little silt, rootlets noted
4				2'10" Very dense gray moist to wet SILT, some sand, some gravel, trace clay, numerous cobbles, boulders noted at 2'10"
6				
8				7'8" Test Pit Terminated at 7'8"
10				
12

1. Sides vertical upon completion.
2. Dry on completion.
3. Staked location and elevation provided by Costich Engineering, Land Surveying & Landscape Architecture, D.P.C.

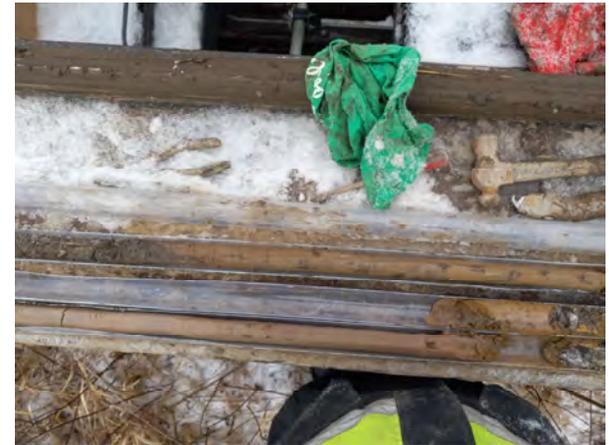
1. Sides vertical upon completion.
2. Dry on completion.
3. Staked location and elevation provided by Costich Engineering, Land Surveying & Landscape Architecture, D.P.C.

Depth Below Surface	Sample Number	Depth of Sample	Soil and Rock Classifications
			Remarks
			TOPSOIL
2			Medium to stiff brown-pale red moist to wet CLAY, little silt 1'0"
4			
6			PP: 4.0 tons/f ² 6'8"
8			Very dense brown-gray wet SILT, some gravel, little to some sand, trace clay 7'8"
10			Terminated at 7'8" (Refusal)
12

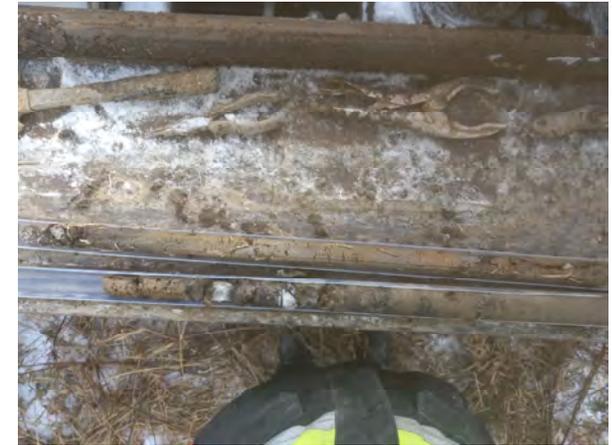
Depth Below Surface	Sample Number	Depth of Sample	Soil and Rock Classifications Remarks
2			TOPSOIL Stiff brown-gray-pale red moist to wet CLAY, little silt 0'6"
4			PP: 4.0 tons/f ² 4'0"
6	S-1	5'0"	Compact to dense brown-gray wet SILT, some gravel, little to some sand, trace clay
8			8'0"
10			Terminated at 8'0" (Refusal on Cobbles)
12

1. Sides vertical upon completion.
2. Dry on completion.
3. Staked location and elevation provided by Costich Engineering, Land Surveying & Landscape Architecture, D.P.C.

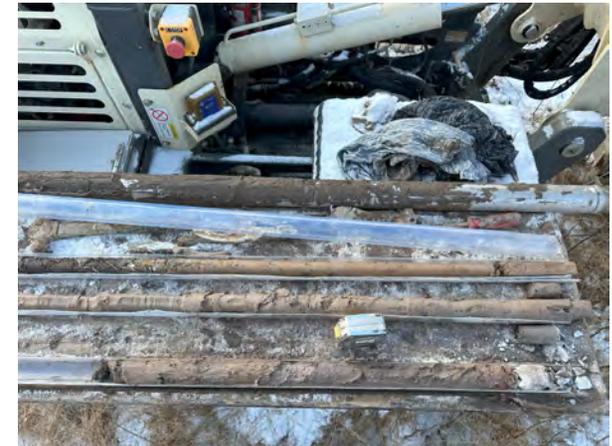
Depth Below Surface	Sample Number	Depth of Sample	Soil and Rock Classifications
			Remarks
2			TOPSOIL 1'0" Firm brown-gray moist to wet SILT, little to some clay, trace gravel, rootlets noted
4			4'0" Stiff gray-brown wet CLAY, little to some silt
6			8'0" Compact gray-brown moist to wet SILT, some gravel, little to some sand, trace to little clay 6" grey saturated SILT layer noted at 10'6" to 11'
10			12'0" Terminated at 12'0"

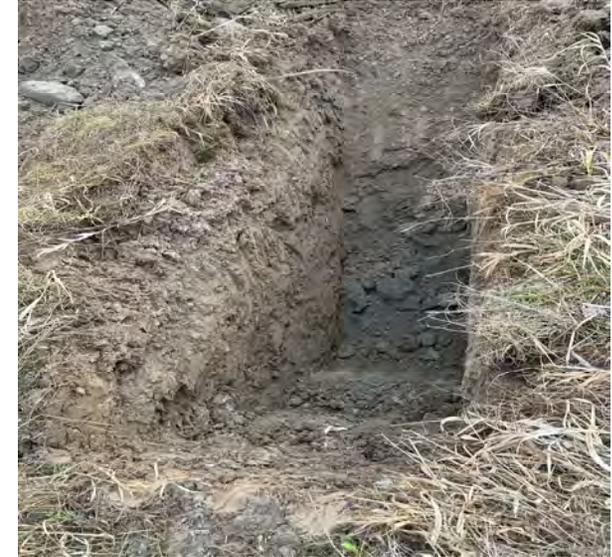
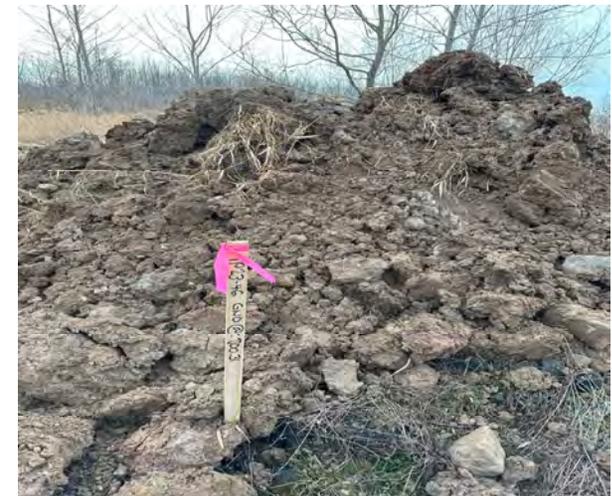
Depth Below Surface	Sample Number	Depth of Sample	Soil and Rock Classifications Remarks
			TOPSOIL
2			1'0" Medium gray-pale red moist to wet CLAY, some silt, little gravel, rootlets noted
4			2'8" Dense brown wet SILT, little to some sand, some gravel, numerous cobbles
6			5'5" Hard gray wet CLAY, some silt, some gravel, rootlets noted
8			(Few boulders at 6'6") 7'6" Very dense gray-brown wet SILT, some gravel, some sand, trace clay, numerous cobbles
10			9'2" Test Pit Terminated at 9'2"
12

1. Sides vertical upon completion.
2. Dry on completion.
3. Staked location and elevation provided by Costich Engineering, Land Surveying & Landscape Architecture, D.P.C.

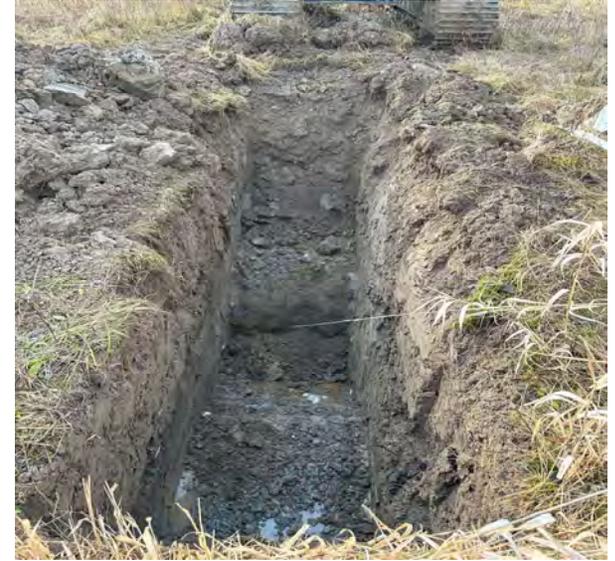
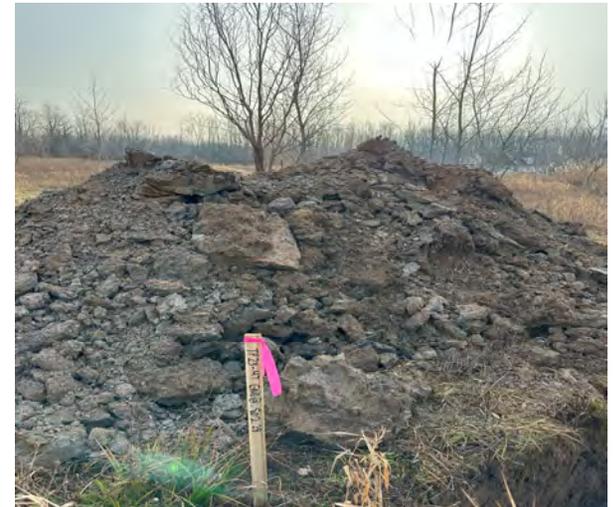
Depth Below Surface	Sample Number	Depth of Sample	Soil and Rock Classifications
			Remarks
			TOPSOIL
2			1'0" Dense brown moist to wet SAND, some silt, little to some gravel, trace clay
4			
6			4'2" Hard gray-brown wet CLAY, little silt, trace sand, rootlets/organics noted
8			(Boulder at 6'7")
10			8'0" Very dense gray-brown wet SILT, some gravel, some sand, trace clay
12			9'6" Test Pit Terminated at 9'6"

1. Sides vertical upon completion.
2. Water seepage at 2'6".
3. Staked location and elevation provided by Costich Engineering, Land Surveying & Landscape Architecture, D.P.C.

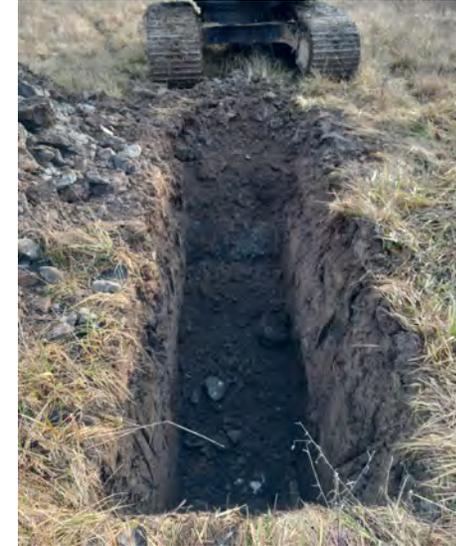
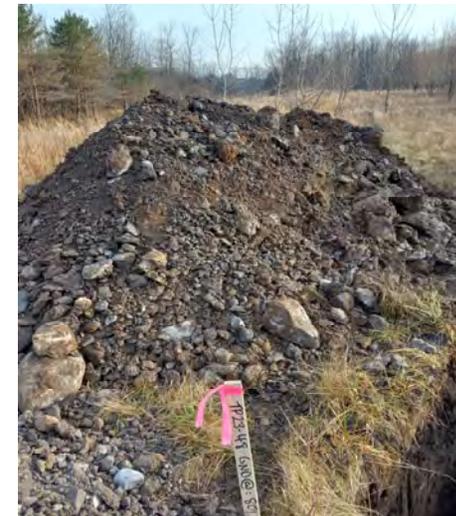
Depth Below Surface	Sample Number	Depth of Sample	Soil and Rock Classifications Remarks
2			TOPSOIL 0'1" FILL: Compact brown wet SILT, little to some gravel, little to trace clay
4			3'2" Medium gray-pale red-brown moist to wet CLAY, some silt, little gravel, trace sand PP: 4.0 tons/f ² TV: 1.55 kg/cm ² (Clay drainage pipe noted at 4'6")
6			
8			6'8" Very dense gray wet SILT, some gravel, little to some sand, trace clay
10	S-1	8'4"	
12			9'6" Test Pit Terminated at 9'6"

1. Sides vertical upon completion.
2. Water seepage at 4'6".
3. Staked location and elevation provided by Costich Engineering, Land Surveying & Landscape Architecture, D.P.C.

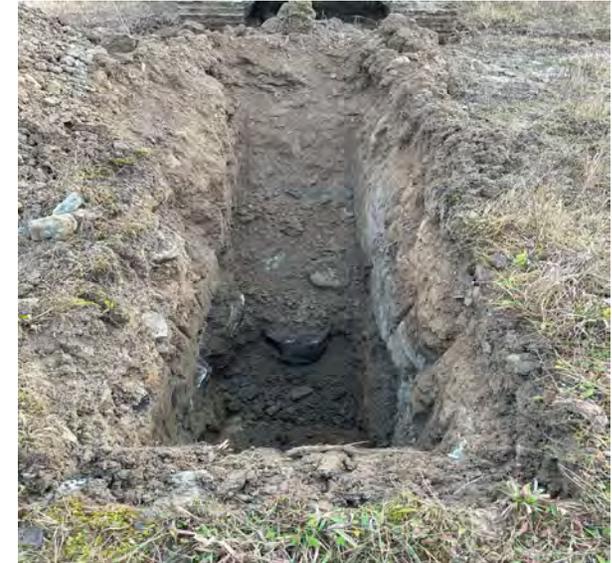
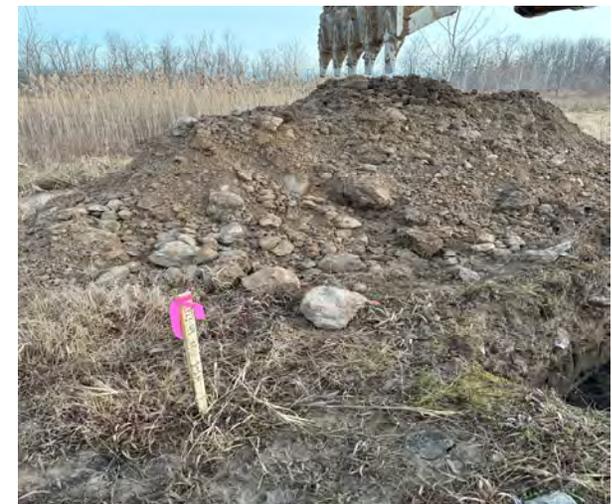
Depth Below Surface	Sample Number	Depth of Sample	Soil and Rock Classifications Remarks
			TOPSOIL (standing water at surface)
2			1'0" Firm gray-brown wet SILT, some sand, some gravel, numerous cobbles
4	S-1	4'0"	3'6" Medium brown moist to wet CLAY with some gravel, trace organics PP: 3.5 tons/f ² TV: 1.5 kg/cm ² (Clay pipe at 4'6")
6			
8			
10	S-2	8'6"	8'6" Dense wet SILT, some sand, some gravel, few boulders
12			10'9" Test Pit Terminated at 10'9"

1. Sides vertical upon completion.
2. Water seepage at 8'0".
3. Staked location and elevation provided by Costich Engineering, Land Surveying & Landscape Architecture, D.P.C.

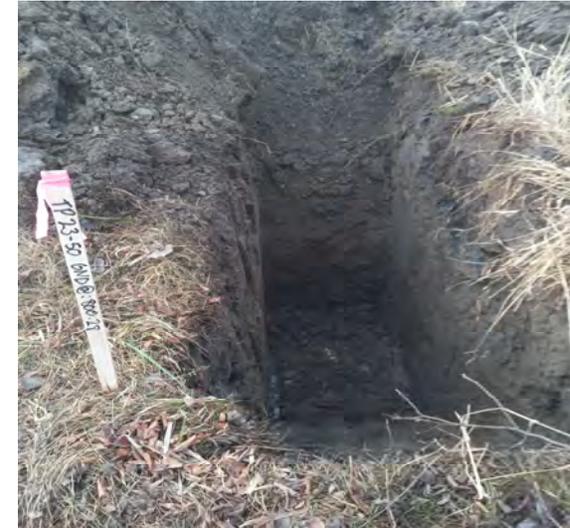
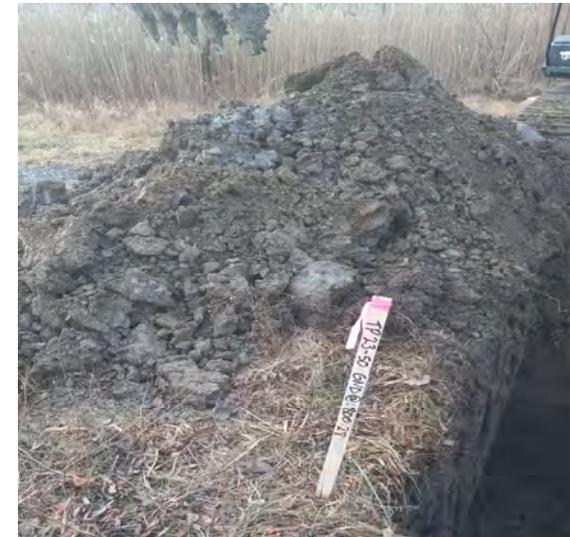
Depth Below Surface	Sample Number	Depth of Sample	Soil and Rock Classifications Remarks
2			TOPSOIL <hr/> 1'0" Medium gray-brown moist to wet CLAY, some silt, trace sand, organics noted PP: 3.0 tons/f ²
4	S-1	4'0"	
6			
8	S-2	8'0"	Very hard, trace gravel at 8'
10			<hr/> 9'4" Test Pit Terminated at 9'4"
12

1. Sides vertical upon completion.
2. Water seepage at 3'0".
3. Staked location and elevation provided by Costich Engineering, Land Surveying & Landscape Architecture, D.P.C.

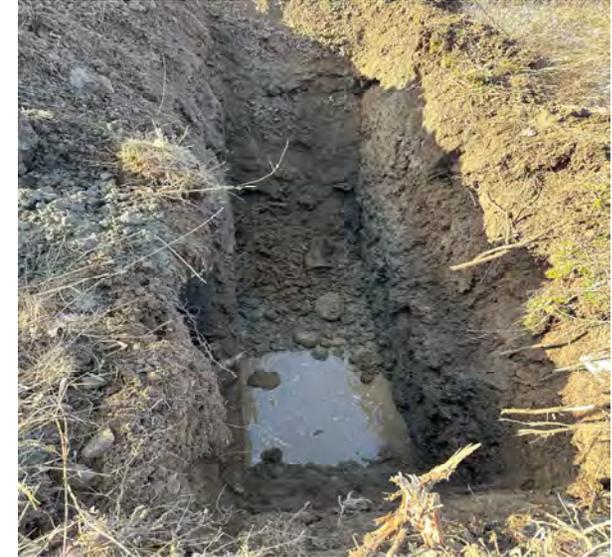
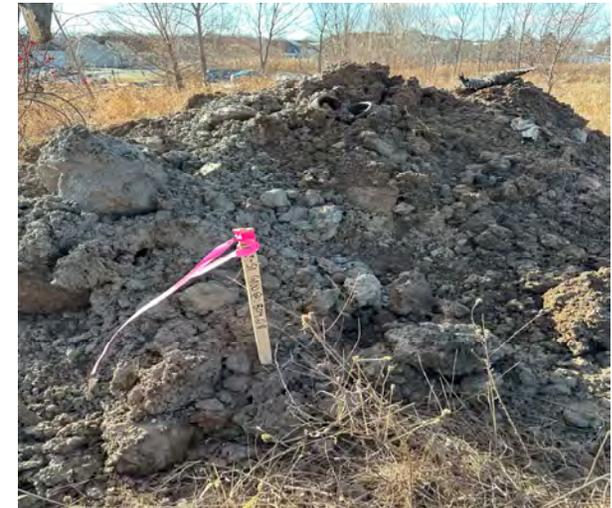
Depth Below Surface	Sample Number	Depth of Sample	Soil and Rock Classifications Remarks
2			TOPSOIL 1'0"
4			FILL: Dense gray-brown wet SILT, some sand, some gravel, trace to little clay, numerous cobbles, plastic piping, concrete block
6			5'0" Very dense gray saturated SILT, some sand, some gravel, trace to little clay
8			(Boulders at 5'2")
10			8'3" Test Pit Terminated at 8'3"
12

1. Sides vertical upon completion.
2. Water seepage at 5'0".
3. Staked location and elevation provided by Costich Engineering, Land Surveying & Landscape Architecture, D.P.C.

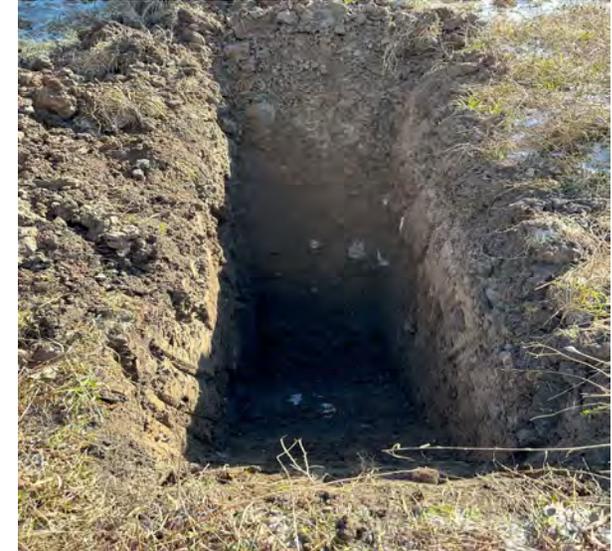
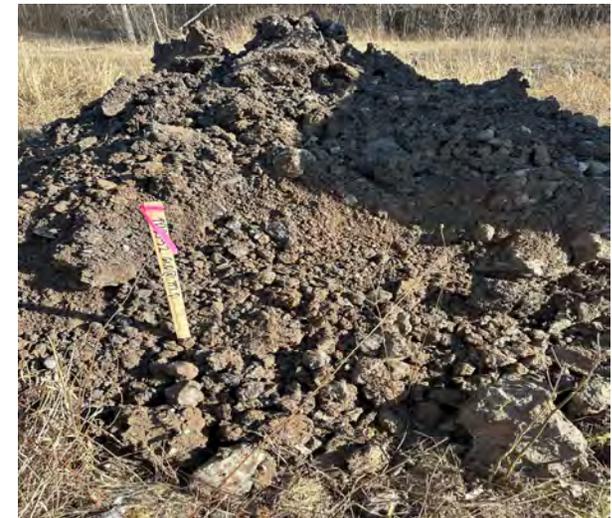
Depth Below Surface	Sample Number	Depth of Sample	Soil and Rock Classifications
			Remarks
2			TOPSOIL <hr/> 1'0" Medium brown-gray wet CLAY, little to some silt, rootlets noted
4	S-1 S-2	3'2" 4'0"	<hr/> 3'10" Dense to very dense gray-brown wet SILT, some sand, some gravel, trace to little clay, little cobbles, boulders noted
6			
8			
10			<hr/> 8'10" Test Pit Terminated at 8'10"
12

1. Sides vertical upon completion.
2. Dry on completion.
3. Staked location and elevation provided by Costich Engineering, Land Surveying & Landscape Architecture, D.P.C.

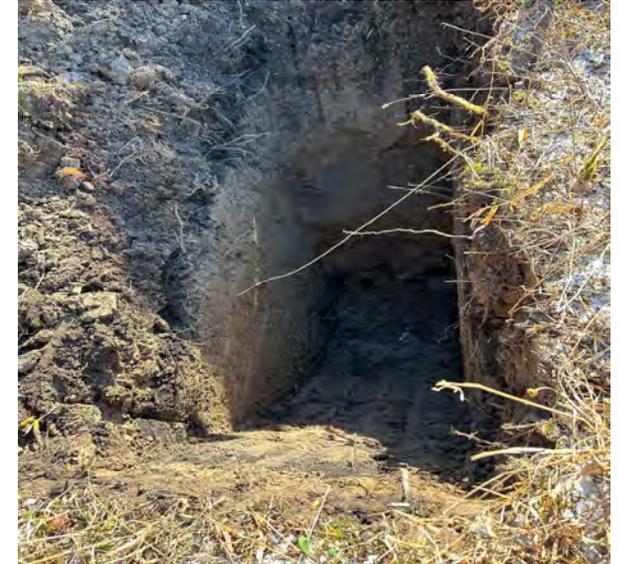
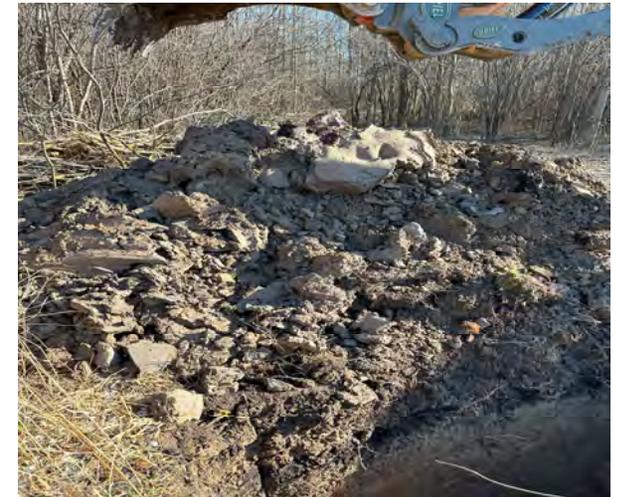
Depth Below Surface	Sample Number	Depth of Sample	Soil and Rock Classifications Remarks
2			FILL: Loose brown wet SILT, some sand, some gravel, rootlets noted 1'6"
4	S-1	2'4"	TOPSOIL, rootlets noted 2'6" Medium gray-brown wet CLAY, little to some silt
6			
8			
10			9'5" Dense gray-brown wet SILT, some sand, some gravel, boulder noted 9'10"
12			Test Pit Terminated at 9'10"

1. Sides vertical upon completion.
2. Dry on completion.
3. Staked location and elevation provided by Costich Engineering, Land Surveying & Landscape Architecture, D.P.C.

Moisture and Organic Content Test Results		
Boring Number	TP23-10	TP23-53
Sample Number	S-1	S-1
Depth	1'-3'	2'4"
Moisture Content (%)	48.4	53.1
Ash Content (%)	92.6	81.5
Organic Content (%)	7.4	18.5

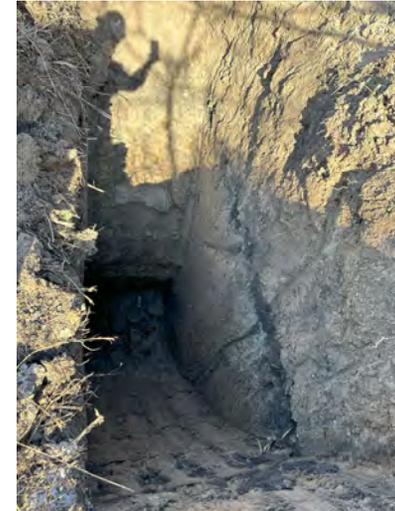
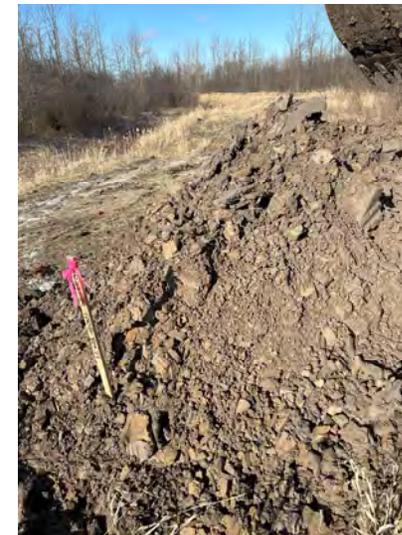
Depth Below Surface	Sample Number	Depth of Sample	Soil and Rock Classifications Remarks
2			FILL: Loose brown-gray moist to wet SILT, some sand, some gravel, rootlets noted 1'0"
4			TOPSOIL, rootlets noted 2'0"
6			Medium gray-brown wet CLAY, little to trace silt
8			
10			Dense to very dense gray wet SILT, some sand, some gravel, trace to little clay, numerous cobbles, boulder noted 9'5" 9'8"
12			Test Pit Terminated at 9'8"

1. Sides vertical upon completion.
2. Dry on completion.
3. Staked location and elevation provided by Costich Engineering, Land Surveying & Landscape Architecture, D.P.C.

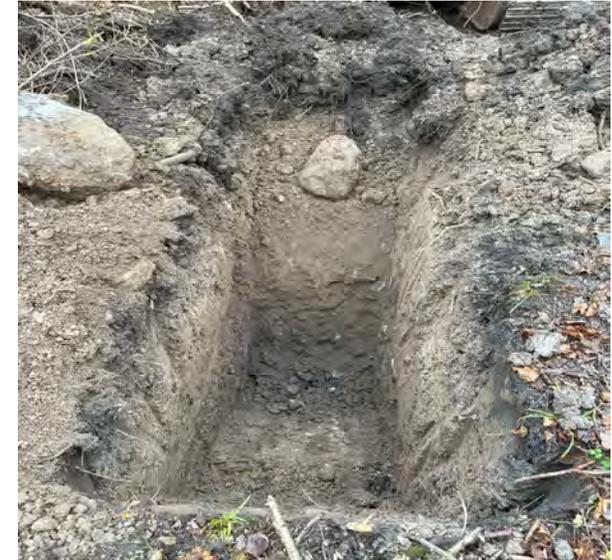
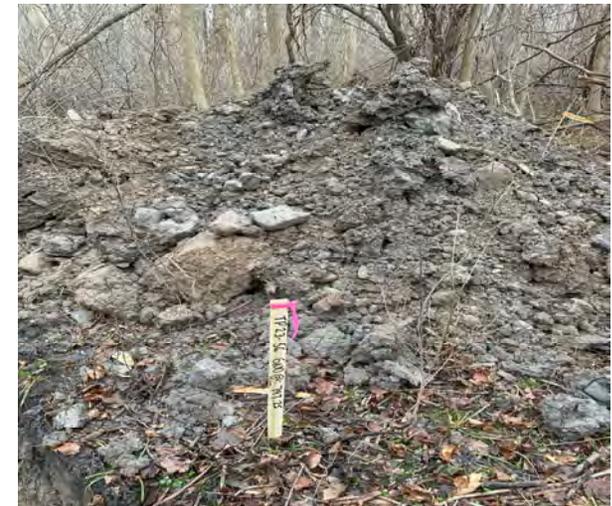
Depth Below Surface	Sample Number	Depth of Sample	Soil and Rock Classifications Remarks
			TOPSOIL
2			Firm brown wet SILT, some clay, little gravel PP: 1.5 tons/f ²
4	S-1	4'0"	Medium gray-brown moist to wet CLAY, some silt, rootlets noted PP: 4.0 tons/f ²
6			Medium pale red wet CLAY, rootlets noted
8			Very dense brown wet SILT, some sand, some gravel, trace to little clay, few cobbles noted
10			Very dense gray wet SILT, some gravel, some sand, trace to little clay, numerous cobbles, few boulders
12			Test Pit Terminated at 9'0"

1. Sides vertical upon completion.
2. Water seepage at 5'6".
3. Staked location and elevation provided by Costich Engineering, Land Surveying & Landscape Architecture, D.P.C.

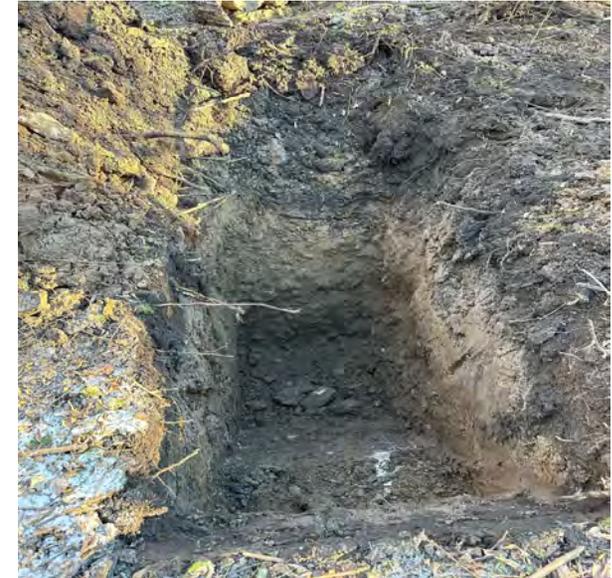
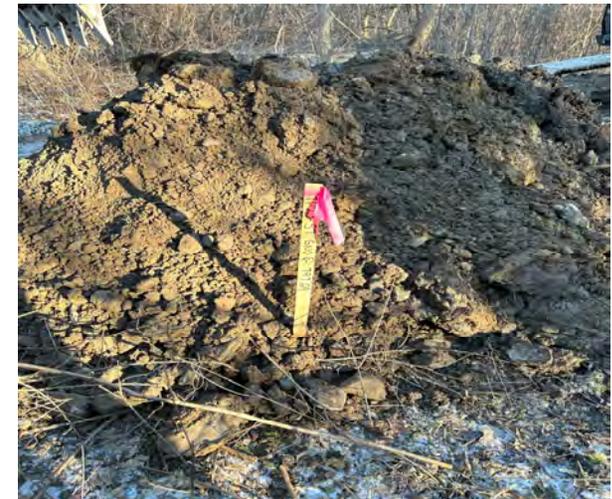
Depth Below Surface	Sample Number	Depth of Sample	Soil and Rock Classifications Remarks
2			TOPSOIL 1'0"
			Medium gray wet CLAY, little to some silt, little gravel
4	S-1	3'7"	PP: 2.0 tons/f ² 3'0" Dense tan wet SILT, some clay, some gravel, rootlets noted
			PP: 4.0 tons/f ² 3'6"
6	S-2	5'2"	Medium pale red wet CLAY, rootlets noted 5'0"
			Very dense gray wet SILT, some clay, some gravel, trace sand, numerous cobbles
8			(Gray at 7'8") 8'0"
10			Test Pit Terminated at 8'0"
12

1. Sides vertical upon completion.
2. Dry on completion.
3. Staked location and elevation provided by Costich Engineering, Land Surveying & Landscape Architecture, D.P.C.

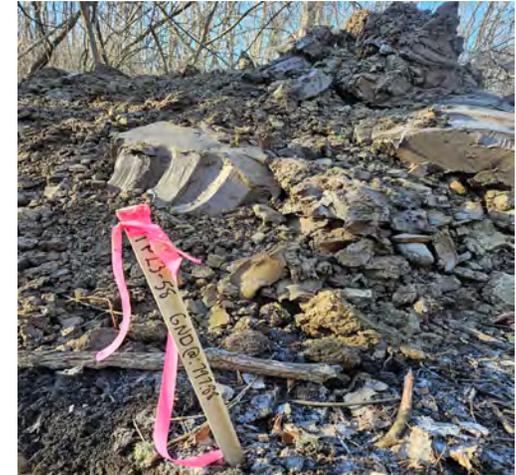
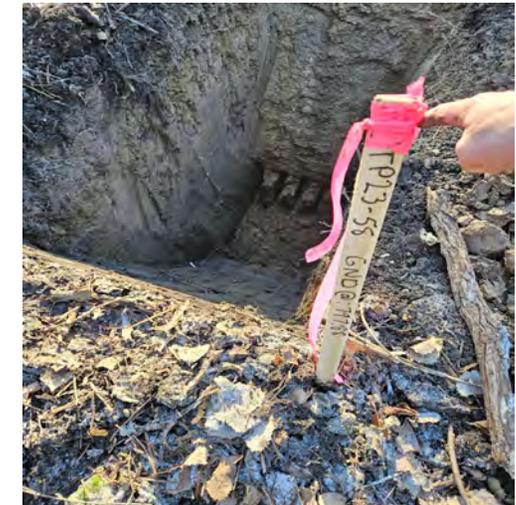
Depth Below Surface	Sample Number	Depth of Sample	Soil and Rock Classifications Remarks
2			TOPSOIL Soft tan-brown moist to wet CLAY, some silt, trace sand 0'9"
4			
6			
8	S-1	6'-8'	
10			10'0"
12			Compact brown moist SILT, some sand, trace gravel, trace cobbles, trace clay 11'0" Test Pit Terminated at 11'0"

1. Sides vertical upon completion.
2. Dry on completion.
3. Staked location and elevation provided by Costich Engineering, Land Surveying & Landscape Architecture, D.P.C.

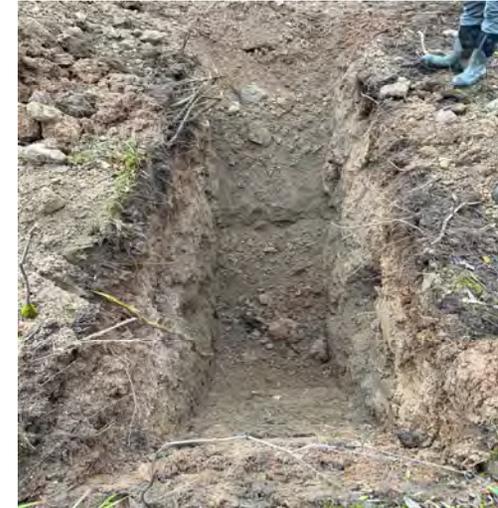
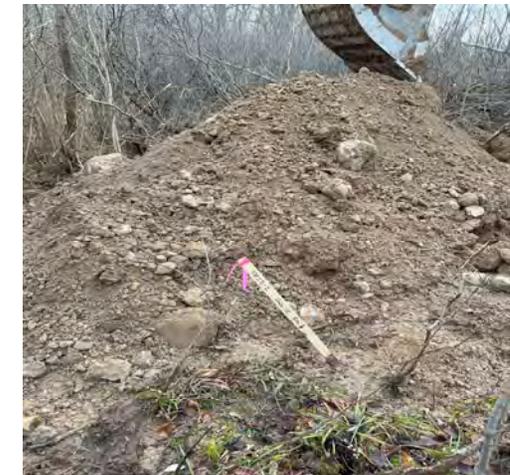
Depth Below Surface	Sample Number	Depth of Sample	Soil and Rock Classifications Remarks
			TOPSOIL
2			Medium red wet CLAY, some gravel, trace sand, trace silt, rootlets noted
4			(Boulders at 3'6")
6			Very dense gray-brown wet SILT, some gravel, little to some sand, trace clay
8	S-1	8'0"	
10			Test Pit Terminated at 9'1"
12

1. Sides vertical upon completion.
2. Dry on completion.
3. Staked location and elevation provided by Costich Engineering, Land Surveying & Landscape Architecture, D.P.C.

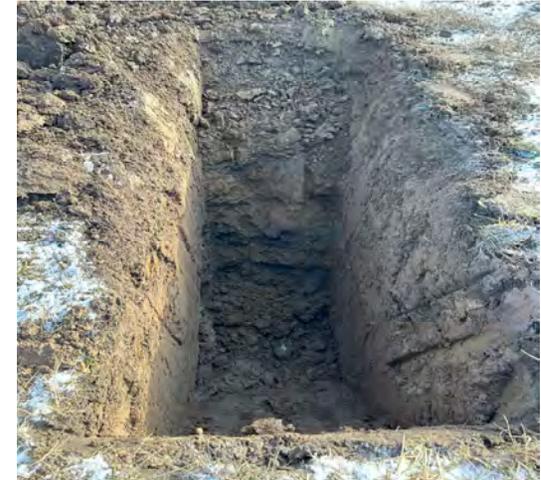
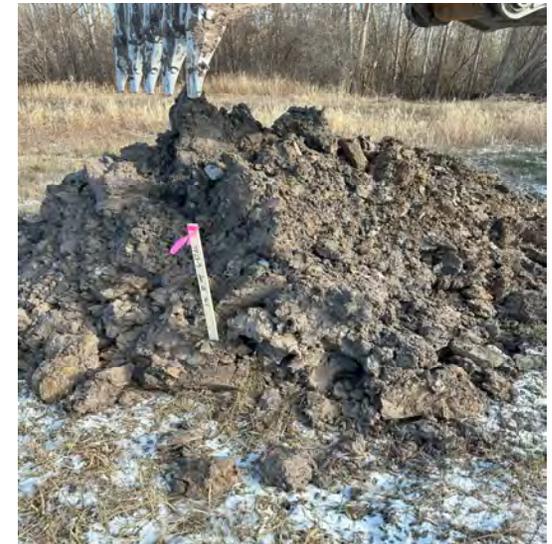
Depth Below Surface	Sample Number	Depth of Sample	Soil and Rock Classifications Remarks
			TOPSOIL
2			1'0" Dense wet brown-grey SILT, some sand, some gravel, trace to little clay, rootlets noted
4			4'0" Clay drainage pipe noted at 1'6"
6			5'8" Medium gray-brown wet CLAY, some silt, little to some gravel
8			Dense grey-brown wet SILT, some sand, some gravel, trace to little clay, numerous boulders
10			9'6" Test Pit Terminated at 9'6"
12

1. Sides vertical upon completion.
2. Dry on completion.
3. Staked location and elevation provided by Costich Engineering, Land Surveying & Landscape Architecture, D.P.C.

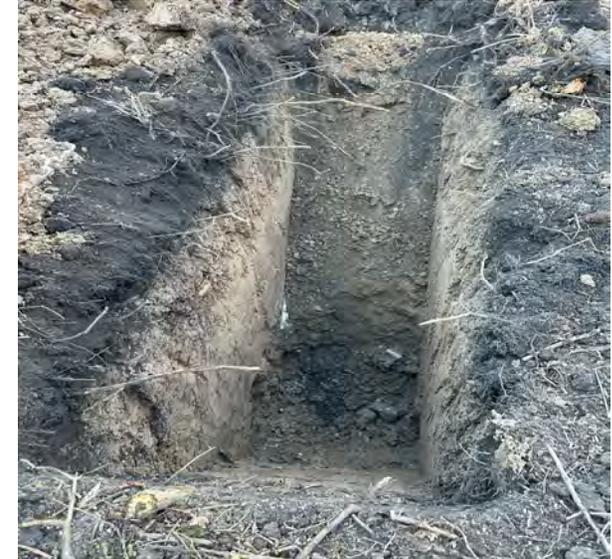
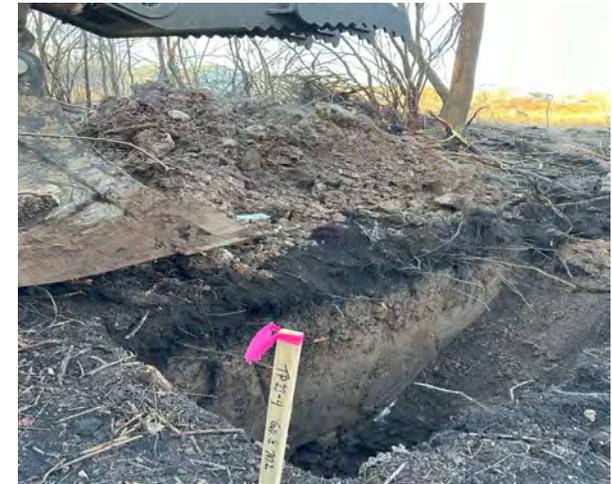
Depth Below Surface	Sample Number	Depth of Sample	Soil and Rock Classifications Remarks
2			TOPSOIL 1'0" Loose to firm brown moist SILT, some sand, some gravel, little clay
4			
6			5'0" Medium gray-brown wet CLAY, little silt, rootlets noted
8			6'6" Very dense gray-brown saturated SILT, some sand, some gravel, trace clay, numerous cobbles (boulder at 7'2")
10			9'6" Test Pit Terminated at 9'6"
12

- Sides vertical upon completion.
- Dry on completion.
- Staked location and elevation provided by Costich Engineering, Land Surveying & Landscape Architecture, D.P.C.

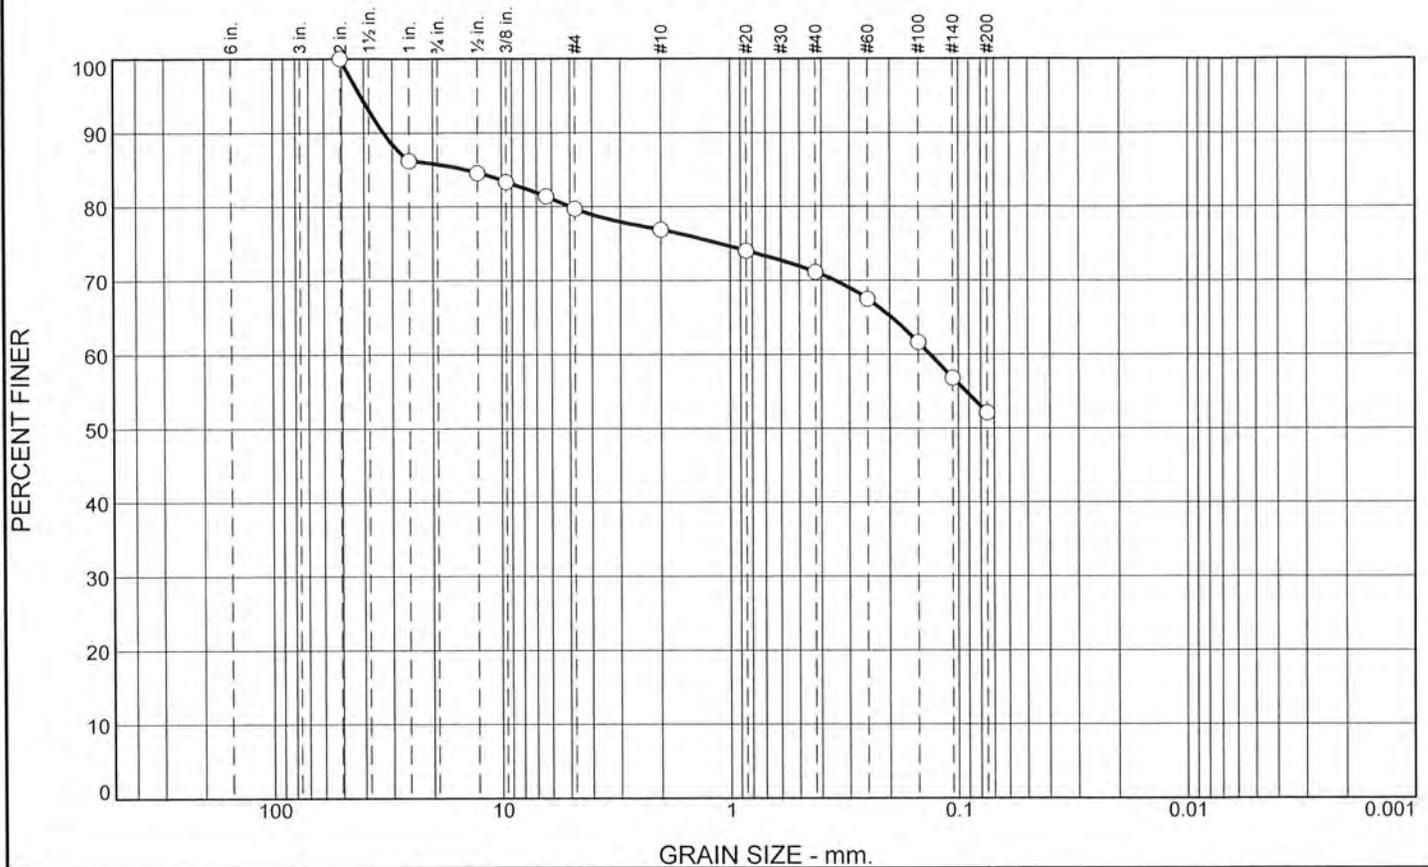
Particle Size Distribution Report

% +3"	% Gravel		% Sand			% Fines	
	Coarse	Fine	Coarse	Medium	Fine	Silt	Clay
0	14	6	3	6	19	52

SIEVE SIZE	PERCENT FINER	SPEC.* PERCENT	PASS? (X=NO)
2"	100		
1"	86		
1/2"	85		
3/8"	83		
1/4"	81		
#4	80		
#10	77		
#20	74		
#40	71		
#60	67		
#100	62		
#140	57		
#200	52

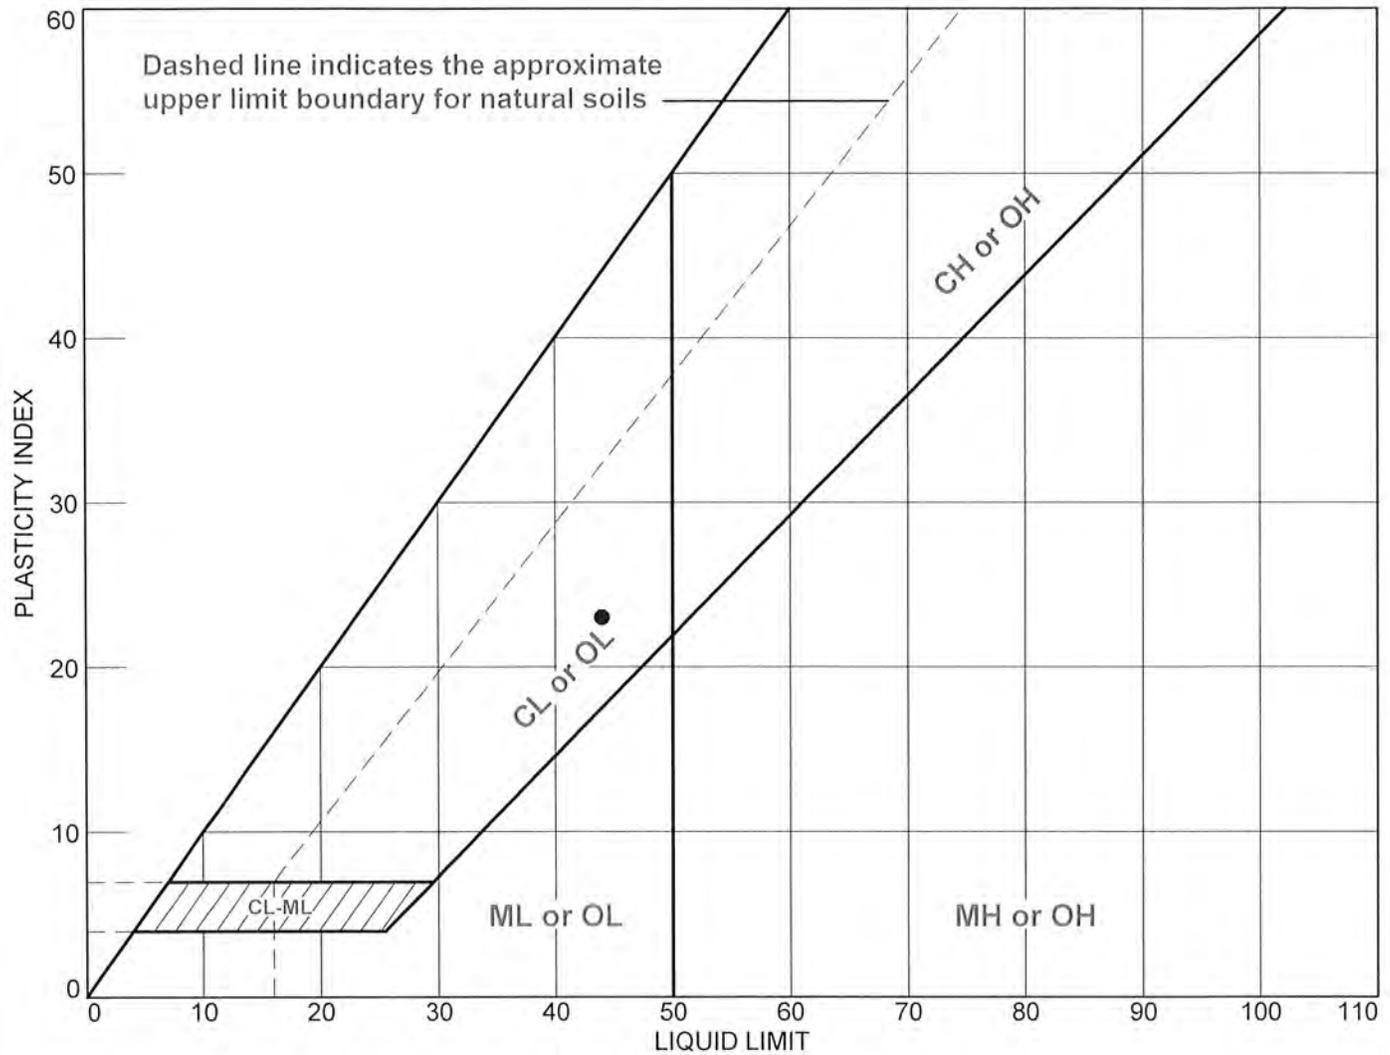
LIQUID AND PLASTIC LIMITS TEST REPORT

SYMBOL	SOURCE	SAMPLE NO.	DEPTH	NATURAL WATER CONTENT (%)	PLASTIC LIMIT (%)	LIQUID LIMIT (%)	PLASTICITY INDEX (%)	USCS
●	TP23-30	S-2	2'4"	21.4	21	44	23	CL

The underlying lake laid silt and clay layer was noted as soft to stiff and moist to saturated. Moisture contents of this layer were between 21.4 and 32.8 percent, well above optimum. This layer was encountered at depths ranging from 2.7 to 15.5 feet below grade. To classify the soils, we performed an Atterberg liquid limit and plastic limit determination tests on three widely spaced locations. TP23-30 and TP23-58 showed fairly similar results of a Plastic Limit (PL) of 21 percent, a Liquid Limit (LL) of 44 and 45, and a Plasticity Index (PI) of 23 and 24 percent, respectfully. Both locations classified as lean clay (CL) in the Unified Soils Classification System. Alternatively, TP23-49 had a PL of 24 percent, a LL of 59 and a PI of 35, classifying this soil as a fatty clay (CH) in the Unified Soils Classification System. Based on PI's above 15, the soils classify as potentially expansive. The potential is even higher based on the PI of 35 at TP23-49. Beneath the clay is a glacial till layer consisting of silt, and clay with sand and gravel. The glacial till rated as firm to very dense and moist to saturated. Testing results showed moisture content ranging from 7.1 to 10.2 percent, near optimum. The soil classified as a CL/ML (sandy silt/clay with gravel) and GM (silty gravel with sand) in the Unified Soils Classification System.
