Foundation Design, P.C.

Reference: North Road Townhouses
156 Stewart Place, Canandaigua, New York
Geotechnical Evaluation, 5552.0

This report summarizes our Geotechnical Evaluation for the referenced project. We understand that the project consists of developing a 27.5-acre parcel into a residential townhouse subdivision. A total of 164 residential units will be constructed, contained in two, four and six unit buildings. The buildings will consist of two to three story, wood framed structures, possibly with basements. New roadways, parking areas, underground utility lines, and stormwater infrastructure will be developed. We base this evaluation on a review of U.S.G.S. topographic and geologic mapping, conceptual site plans, test pit/macro core exploration, laboratory test results, and consultation with the design team. Chrisantha, Inc. retained Foundation Design, P.C. to provide the services outlined in our November 22, 2023, *Geotechnical Services Proposal, P5538.0*. We intend the conclusions and recommendations outlined in this report exclusively for use in the design and construction of this project.

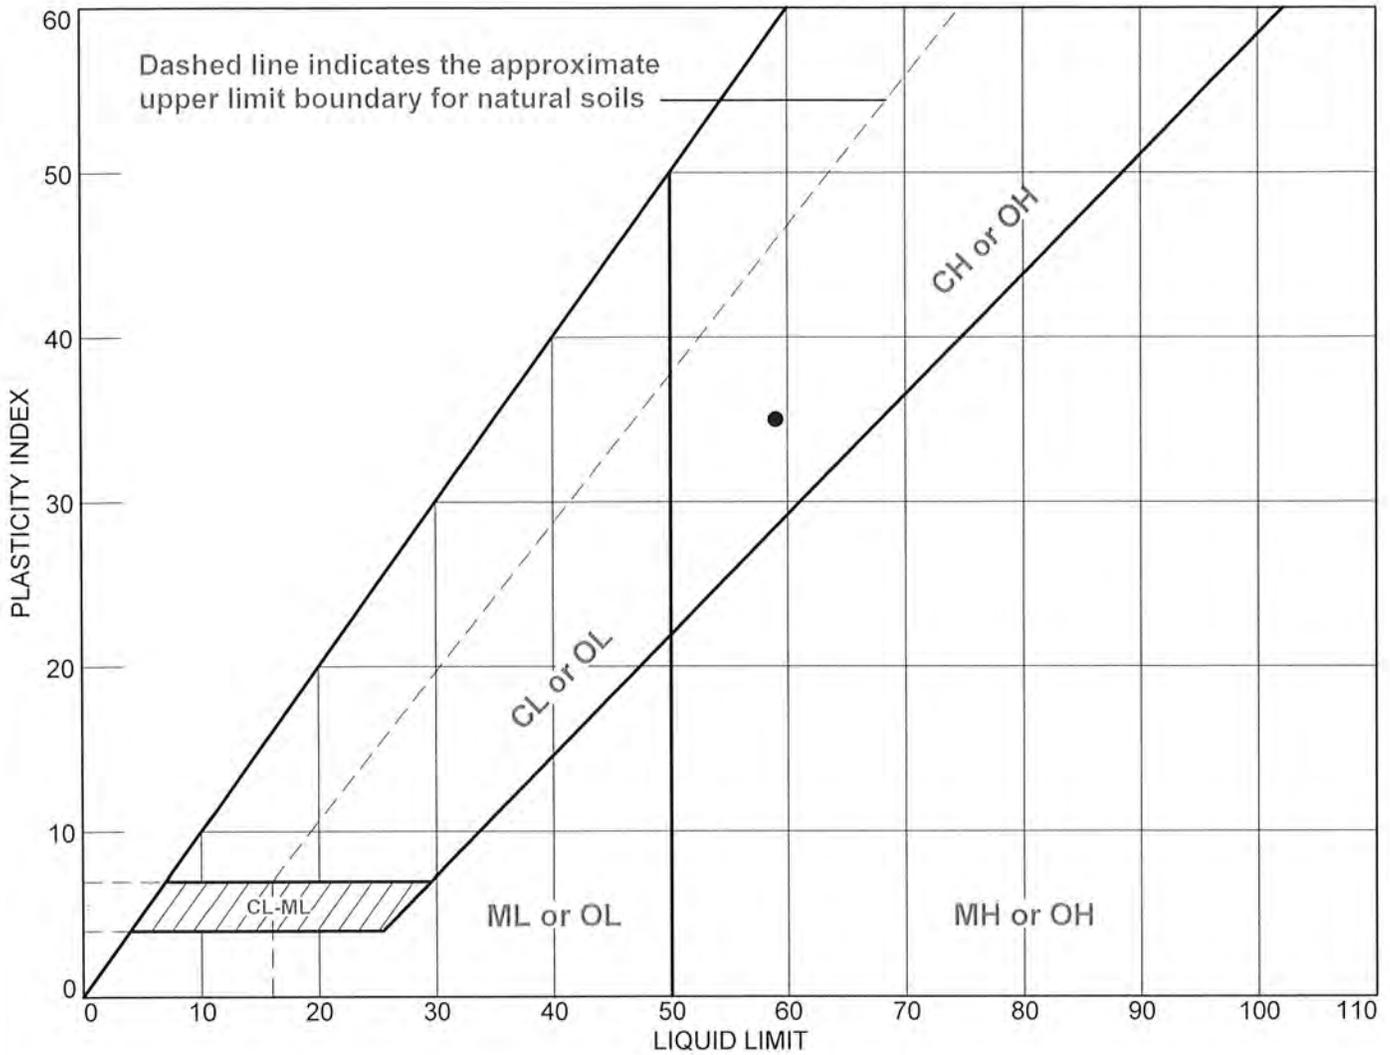
LIQUID AND PLASTIC LIMITS TEST REPORT

SOIL DATA								
SYMBOL	SOURCE	SAMPLE NO.	DEPTH	NATURAL WATER CONTENT (%)	PLASTIC LIMIT (%)	LIQUID LIMIT (%)	PLASTICITY INDEX (%)	USCS
●	TP23-49	S-1	4'	30.0	24	59	35	CH

The underlying lake laid silt and clay layer was noted as soft to stiff and moist to saturated. Moisture contents of this layer were between 21.4 and 32.8 percent, well above optimum. This layer was encountered at depths ranging from 2.7 to 15.5 feet below grade. To classify the soils, we performed an Atterberg liquid limit and plastic limit determination tests on three widely spaced locations. TP23-30 and TP23-58 showed fairly similar results of a Plastic Limit (PL) of 21 percent, a Liquid Limit (LL) of 44 and 45, and a Plasticity Index (PI) of 23 and 24 percent, respectfully. Both locations classified as lean clay (CL) in the Unified Soils Classification System. Alternatively, TP23-49 had a PL of 24 percent, a LL of 59 and a PI of 35, classifying this soil as a fatty clay (CH) in the Unified Soils Classification System. Based on PI's above 15, the soils classify as potentially expansive. The potential is even higher based on the PI of 35 at TP23-49. Beneath the clay is a glacial till layer consisting of silt, and clay with sand and gravel. The glacial till rated as firm to very dense and moist to saturated. Testing results showed moisture content ranging from 7.1 to 10.2 percent, near optimum. The soil classified as a CL/ML (sandy silt/clay with gravel) and GM (silty gravel with sand) in the Unified Soils Classification System.

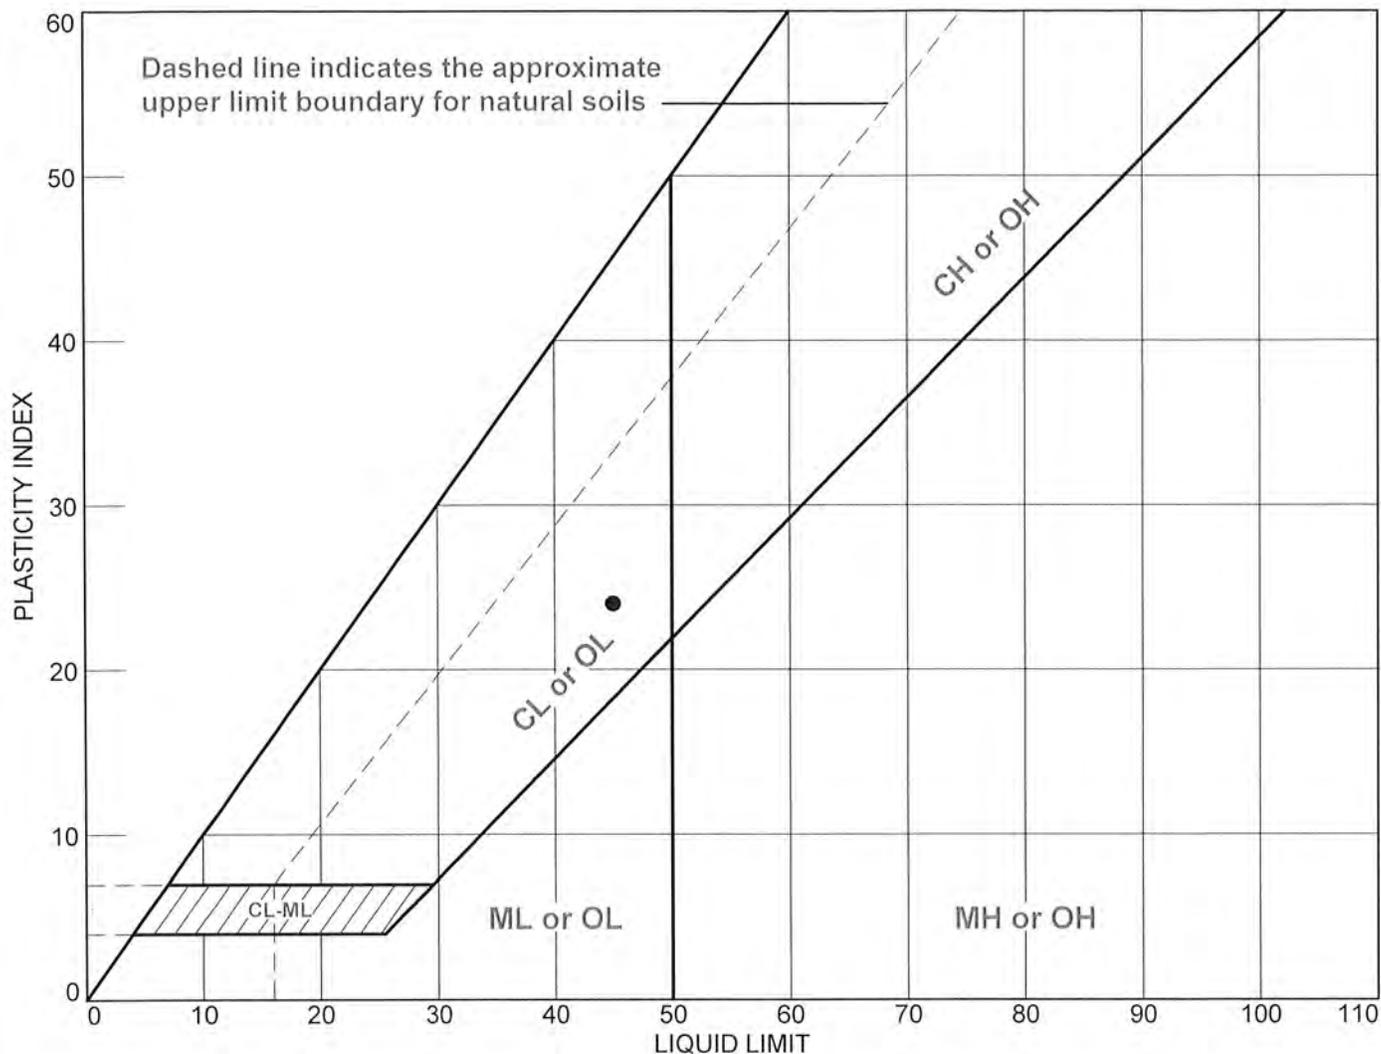
LIQUID AND PLASTIC LIMITS TEST REPORT

SYMBOL	SOURCE	SAMPLE NO.	DEPTH	NATURAL WATER CONTENT (%)	PLASTIC LIMIT (%)	LIQUID LIMIT (%)	PLASTICITY INDEX (%)	USCS
●	TP23-58	S-1	6'8"	32.8	21	45	24	CL
