City of Canandaigua

Natural Resources Inventory

November 2021

Prepared by GreenHows Consulting & Impact Earth
Prepared for the City of Canandaigua Climate Smart Communities Committee

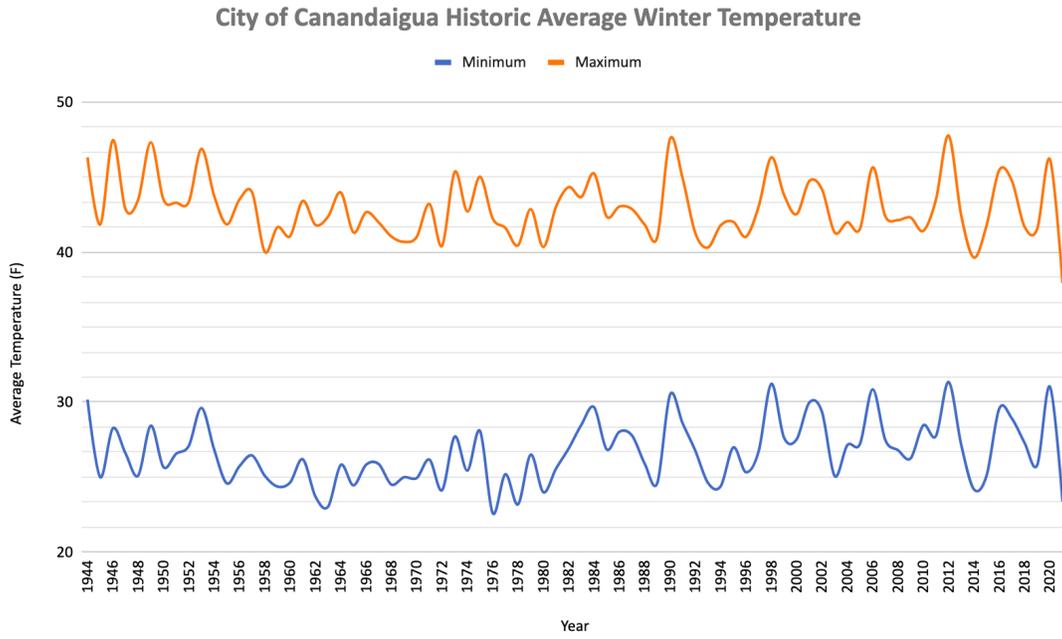
Figure 1: Local Historic Average Winter Temperatures 1944 to 2020

As shown in Figure 1, over the last 80 years, average winter minimum and maximum temperatures have fluctuated as a result of climate change. Most notably is the year-to-year variability in both average highs and average lows. From 1944 to 1988, year-to-year differences in temperature ranged from 2-5 degrees, with few exceptions. Beginning in 1988, however, more drastic year-to-year swings have been observed with 7-9 degree differences.

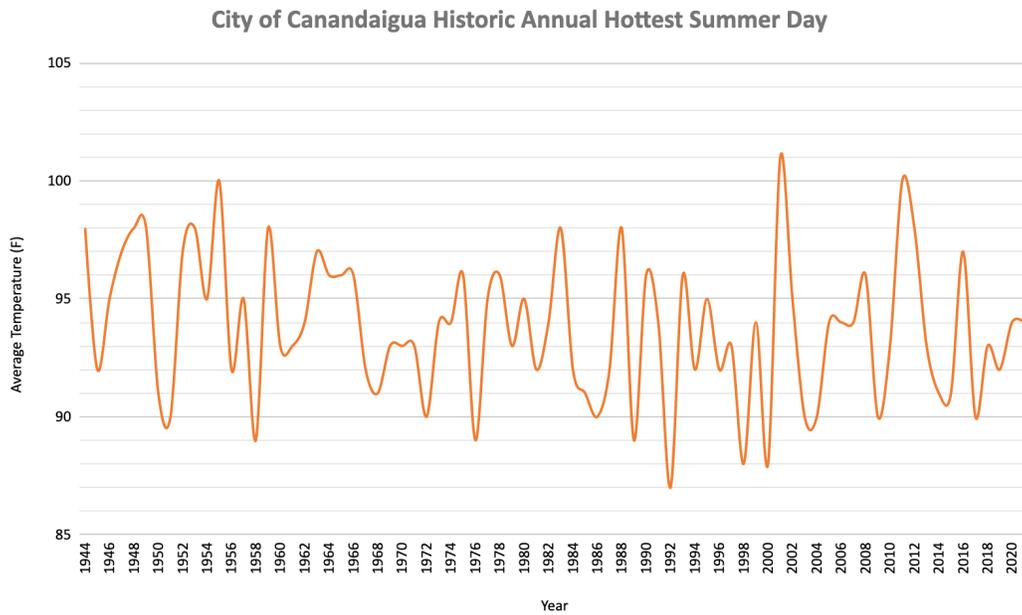
Figure 4: Annual Hottest Summer Day 1944 to 2020

As shown in Figure 4, average summer high temperatures have remained consistent for much of the last eighty years. Before 2000, six summers had an average high temperature at or below 88°F and only one summer has an average high temperature near 100°F. Since 2000, every summer has been warmer than 88°F and two warmer than 100°F.

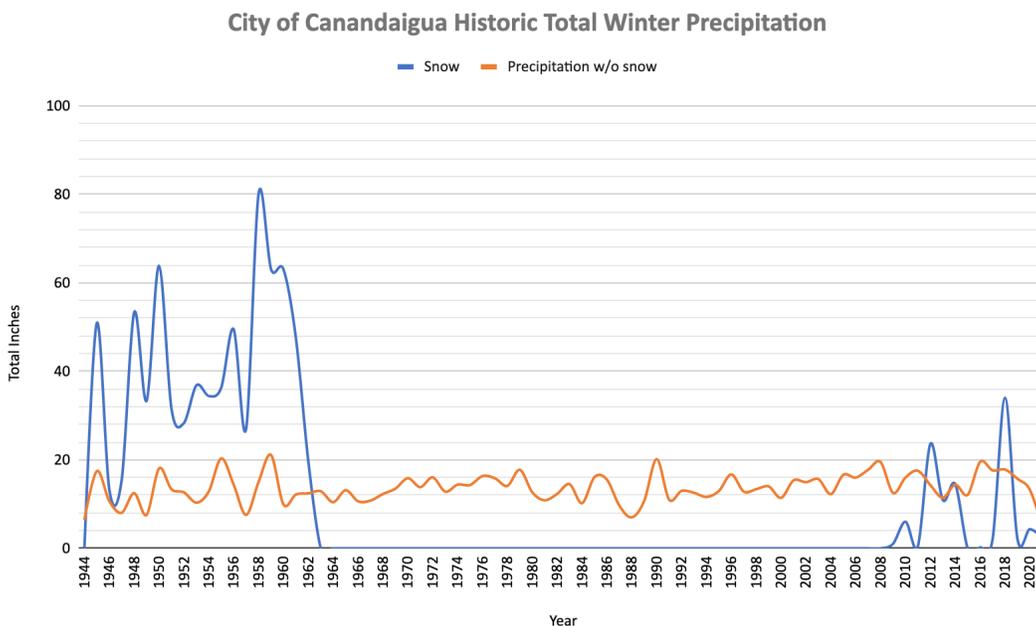
Figure 5: Annual Total Winter Precipitation 1994 to 2020.
Snowfall data is not available from 1963 to 2009.

Climate change has especially affected precipitation in the City of Canandaigua. While data for snowfall between 1963 and 2009 is unavailable, the data from years prior and after shows a clear decrease in snowfall throughout the year and an increase in precipitation, excluding snow, during the summer (See Figure 5). From 1946 to 1963, snowfall ranged from twenty-eight inches to as much as eighty inches. Most years during this timeframe saw between fifty and sixty inches of snow during the winter. After 2009, snowfall during the winter drastically decreased, with the maximum snowfall in one winter being just thirty-six total inches, with all other years being at or below twenty-four inches.

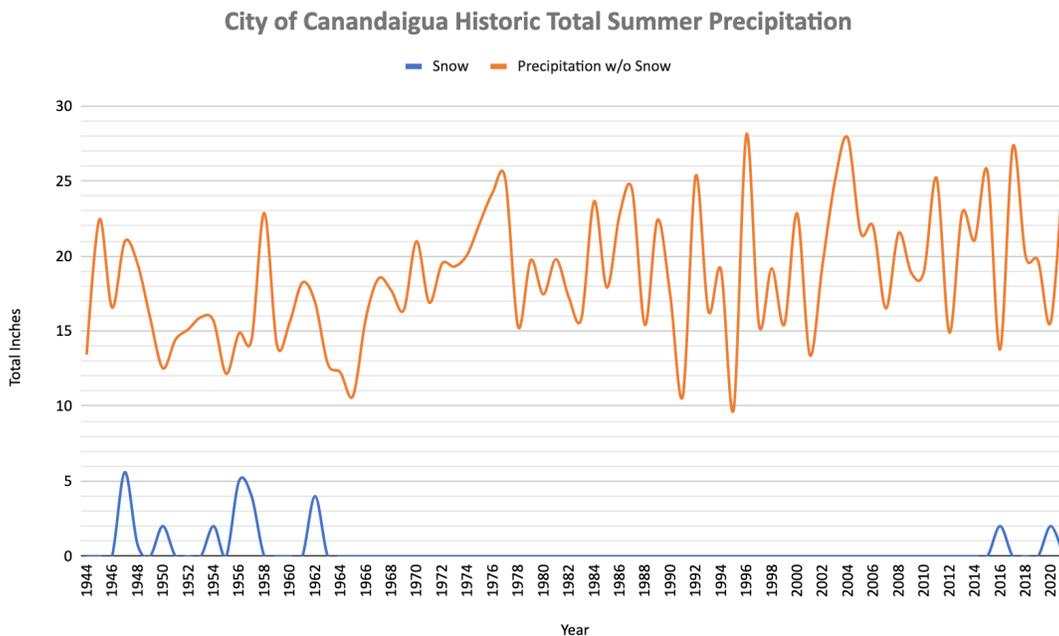
Figure 6: Total Summer Precipitation: 1944 to 2020. Snowfall data is not available from 1963 to 2009.

As shown in Figure 6, late spring and early fall snowfall has also decreased, with regular snowfall accumulating to as much as 5 inches in the 1940’s to just two inches in 2016 and 2020. During summer months, annual precipitation excluding snowfall has increased significantly. Before 1984, the average daily precipitation was approximately 0.08 inches with only 7 years receiving more than twenty inches of precipitation and just one year receiving more than twenty-five inches. After 1984, this average increased to 0.09 inches with 17 years receiving more than 20 inches and 7 years receiving more than 25 inches.

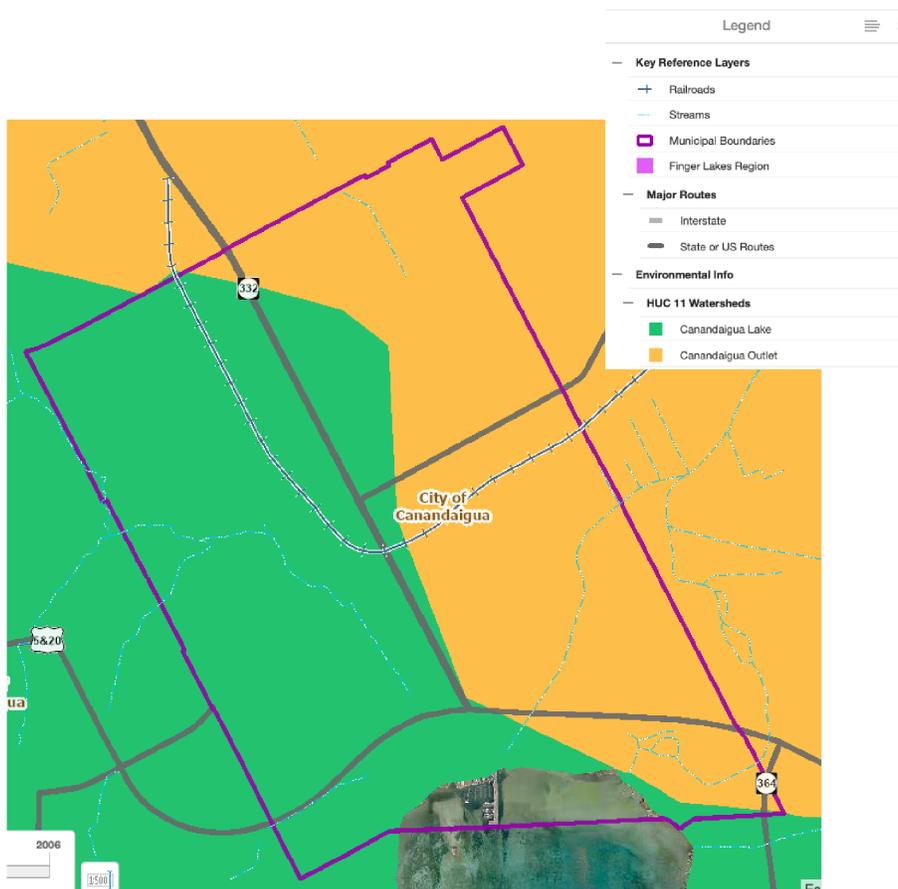
MAP B2: Watershed Map, Ontario County GIS, September 25, 2021

The City of Canandaigua is at the North end of Canandaigua Lake. There are two watersheds within the city limits, the Canandaigua lake watershed and the Canandaigua Outlet watershed. The Canandaigua Outlet watershed transports water out of the lake into the Erie canal and eventually into the Great Lakes. The city controls two flood channels in the Canandaigua Outlet watershed. The Canandaigua lake watershed transports water into the lake through hundreds of tributaries surrounding the lake. A current emerging threat to the city is flooding near the lake and the flood channels. Flooding puts 20% of the city’s properties at risk¹¹.

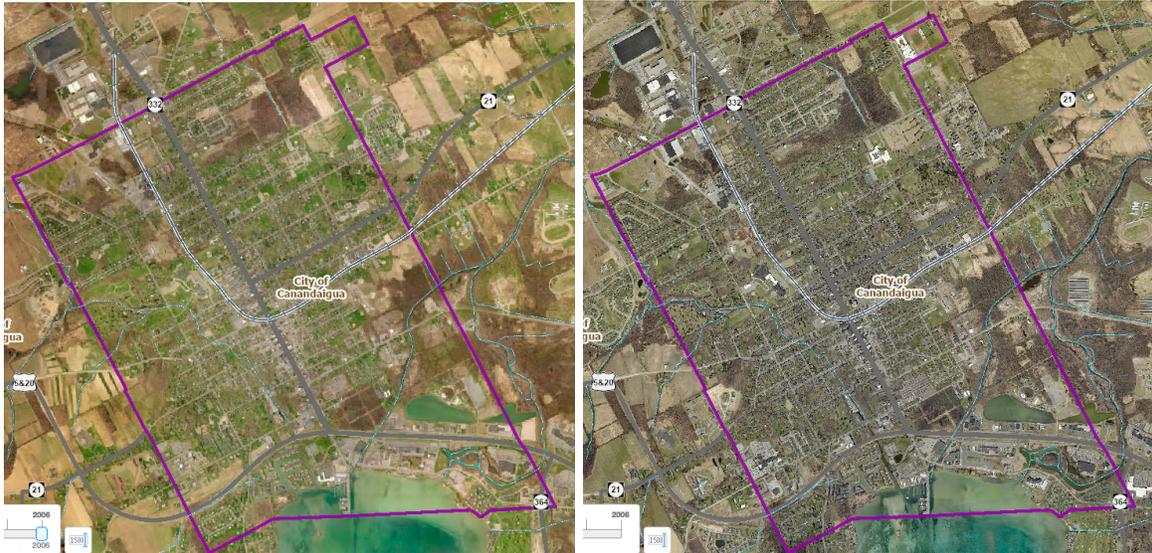
MAP B3: Land Use Changes 2006 to 2021 [index.html](#)

The City has also experienced land use change as population and tourism changes. The following maps show the development growth that the city has been undergoing since 2006. Previous farmland and open grassland, seen in the left hand image, is being developed into mainly residential neighborhoods as seen in the right hand image. A current emerging threat to the city is the loss of biodiversity. Habitat loss is caused by development and invasive species.

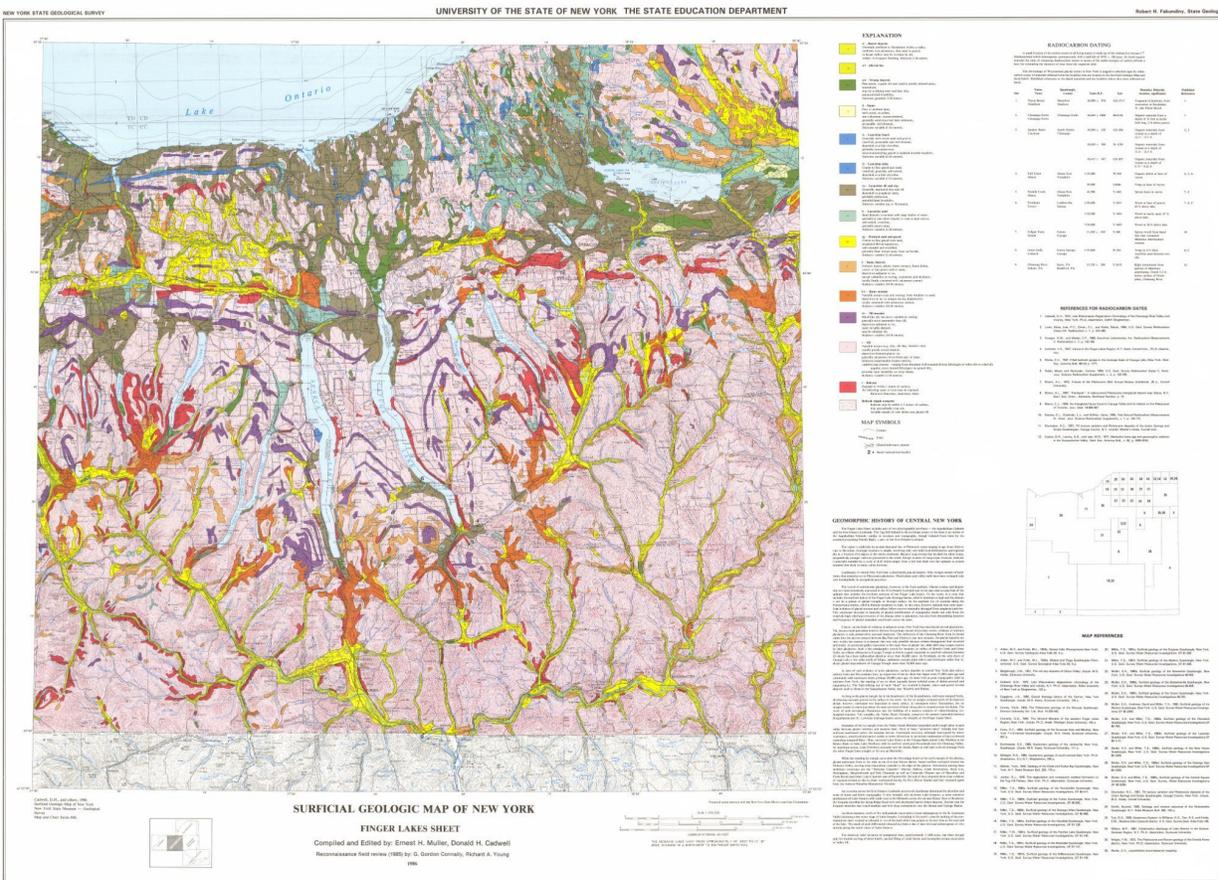
FIGURE GS1: Surficial Geology (Cadwell and others, 1986)

The *Surficial Geologic Map of New York State: Finger Lakes Sheet* shows that the City of Canandaigua has a surface geology consisting primarily of Lacustrine silt and clay. The southwestern boundary of the City lays on a change in surficial geology where till may be found in some areas¹³. This till is classified as calcareous with a calcium carbonate equivalent ranging from 10-30 percent. This till contains free lime at depths of 1 ½ to 2 ½ feet¹⁴.

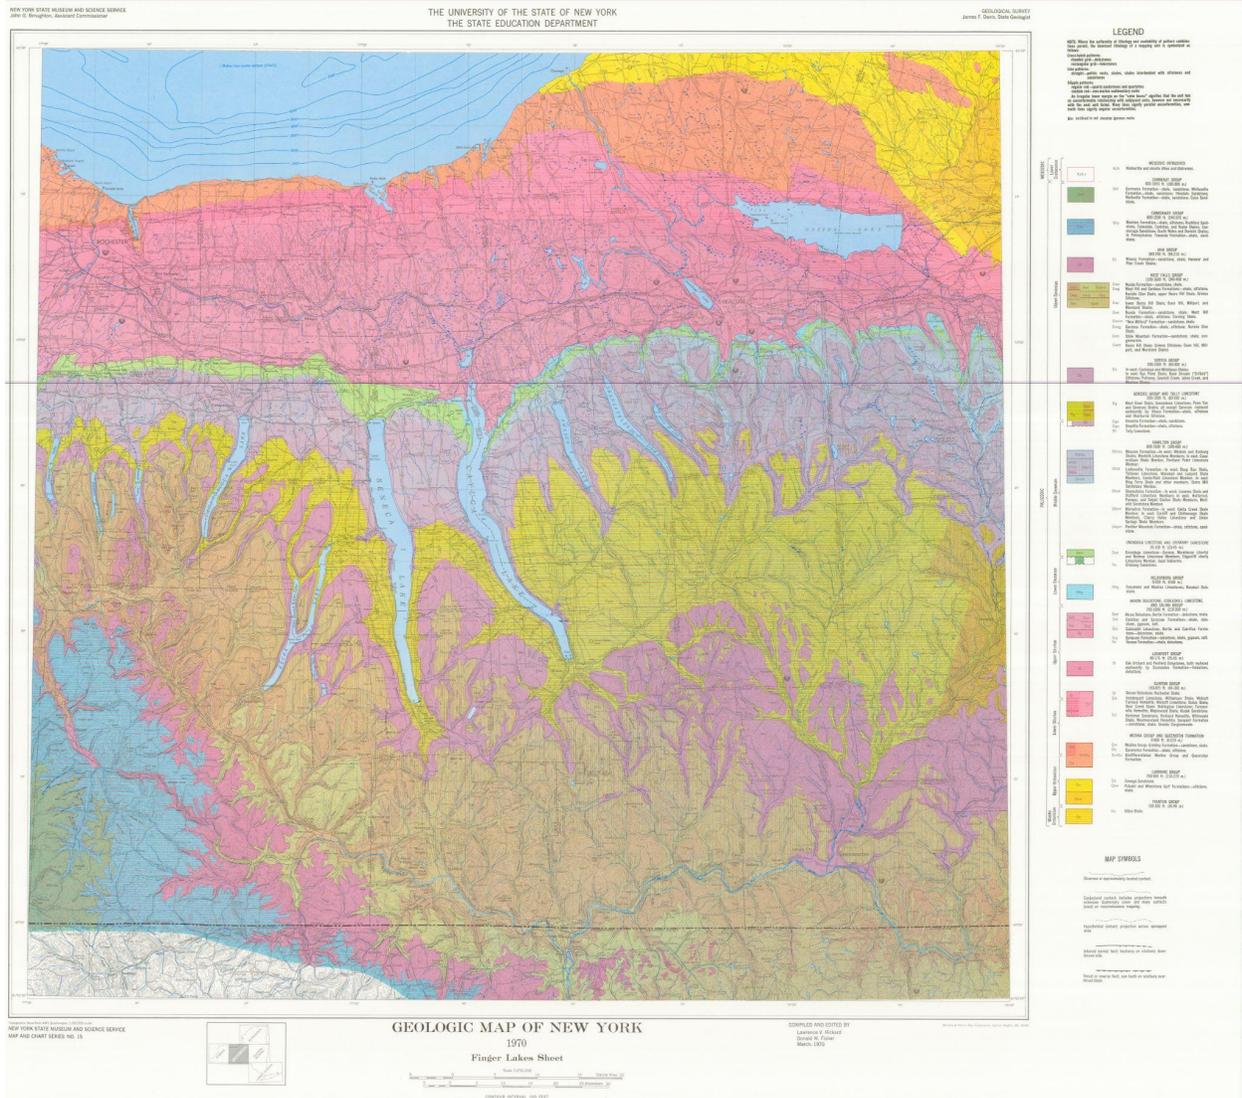
FIGURE GS2: Geologic Survey (Rickard and Fisher 1970)

The *Geologic Map of New York: Finger Lakes Sheet* details the bedrock formations across the region. The predominant bedrock layer found in Canandaigua was formed in the Paleozoic Era, specifically the Middle Devonian Age. This layer, known as the Hamilton Group includes the Skaneateles Formation, made of Levanna Shale and Stafford Limestone Members. In the most western regions of the City of Canandaigua, bedrock may be the younger Ludlowville Formation, which is described as Deep Run Shale, and Tichenor Limestone, with Wanakah and Ledyard Shale Members, and Centerfield Limestone Members. These shale members lay on the northern extent of the Marcellus Shale Formation.

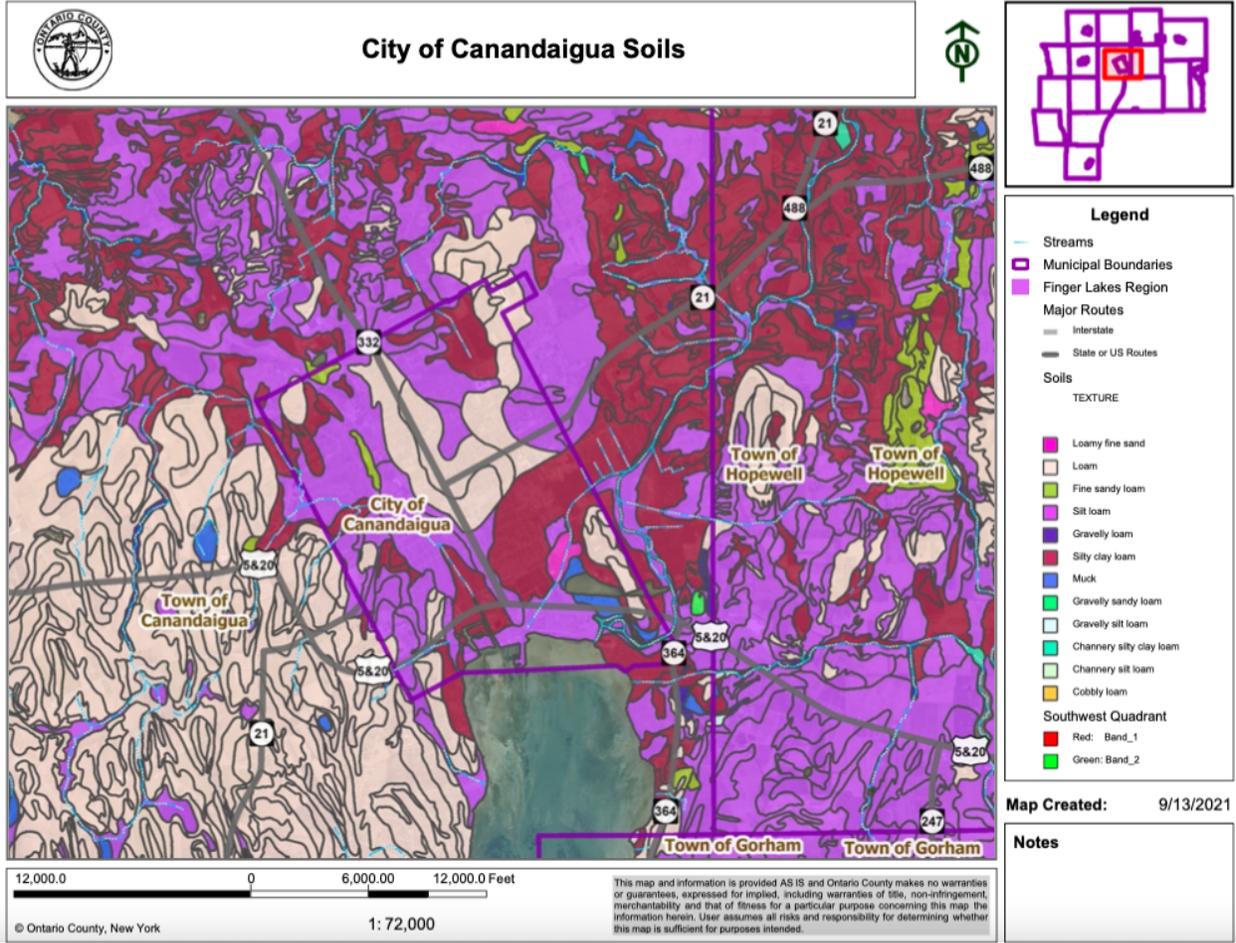
MAP GS1: Soil, developed with Ontario County GIS on September, 13th, 2021

Map GS1 shows the soils in the City of Canandaigua. The predominant soil texture is silt loam with silty clay loam and loam present throughout the City. These textures stem from numerous parent materials, so variety is seen within each of these textures.

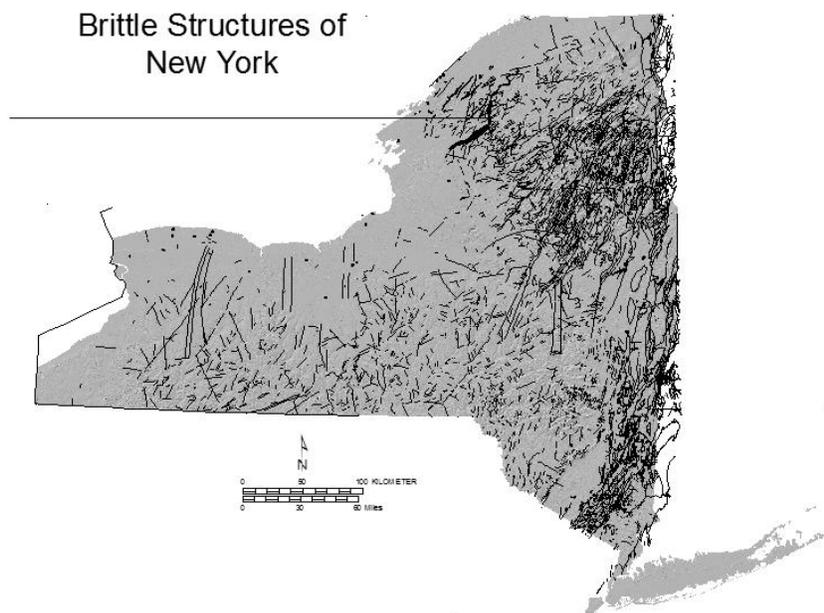
MAP GS2: Brittle Structure of New York¹⁷

The City of Canandaigua is located within 30 miles of several brittle structures, or fault lines, as seen on Map GS2. FEMA has issued an Earthquake Hazard map designating the City of Canandaigua a Seismic Design Category of A/B, seen on Map GS3. An A/B Zone may experience noticeable shaking, moving furniture, and slight damage¹⁶. Canandaigua Lake may experience more drastic tides after seismic activity.

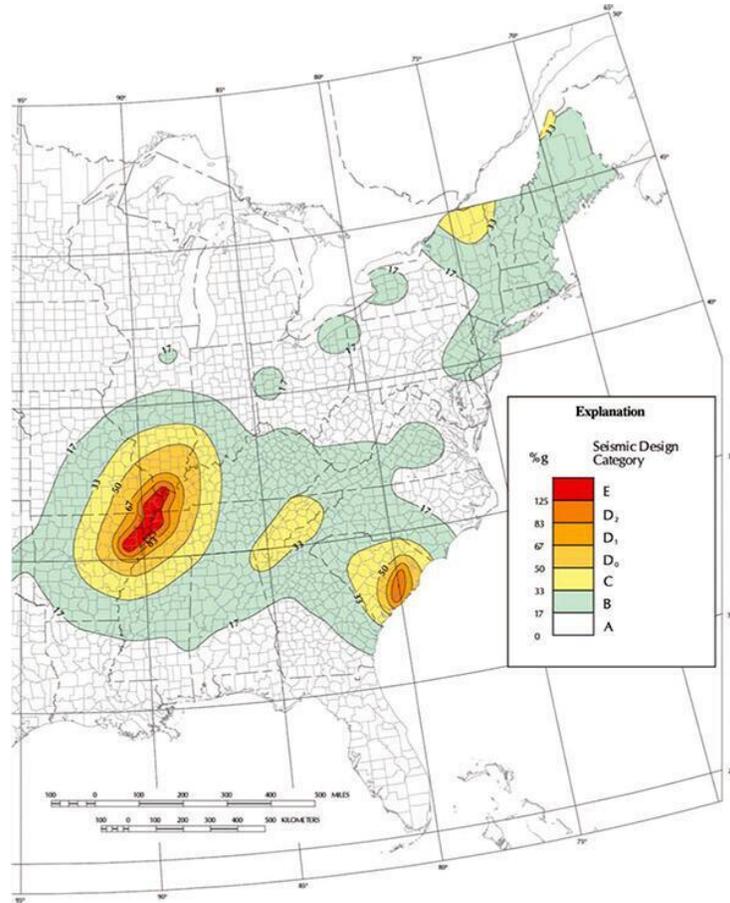
MAP GS3: Earthquake Hazards (FEMA, 2020)

A	Very small probability of experiencing damaging earthquake effects.
B	<p>Could experience shaking of moderate intensity.</p> <p>Moderate shaking—Felt by all, many frightened. Some heavy furniture moved; a few instances of fallen plaster. Damage is slight.</p>

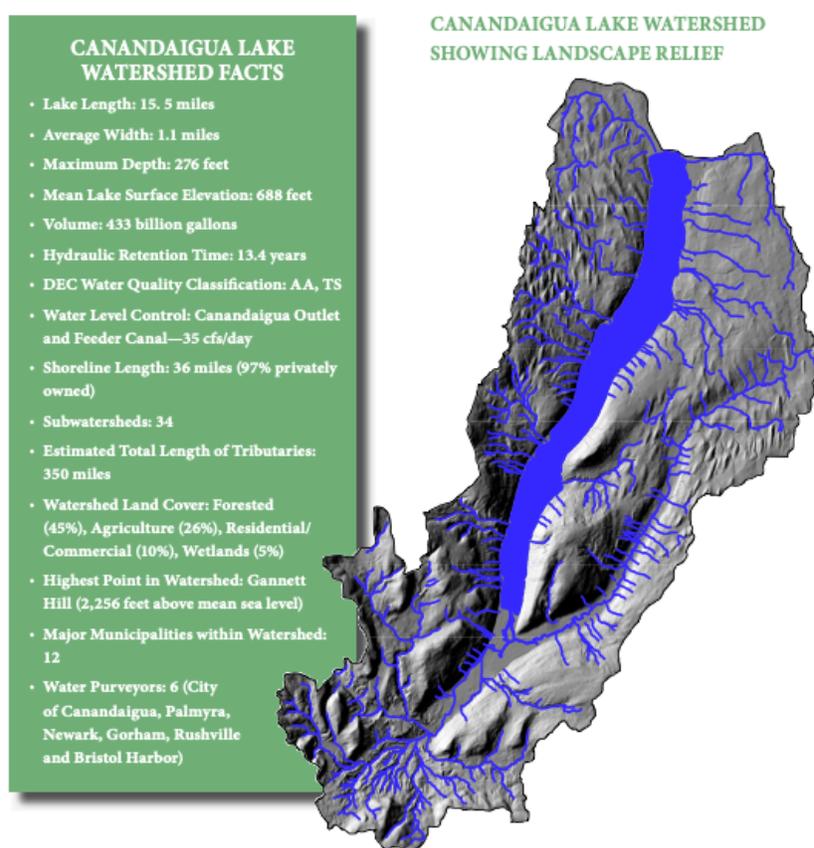
FIGURE LC1: Canandaigua Lake Watershed Facts

The City of Canandaigua is split between the Canandaigua Lake watershed and the Canandaigua Outlet watershed. The Canandaigua Outlet's mouth begins at Canandaigua Lake and exits 34 miles north into the Erie Canal and Clyde River. The City controls an eastern flood channel that flows through Lagoon Park and the western channel at the Feeder Canal. The Canandaigua Lake watershed is surrounded by 8 main tributaries and hundreds of smaller ones¹⁸. The watershed map shows the tributaries feeding into Canandaigua Lake.

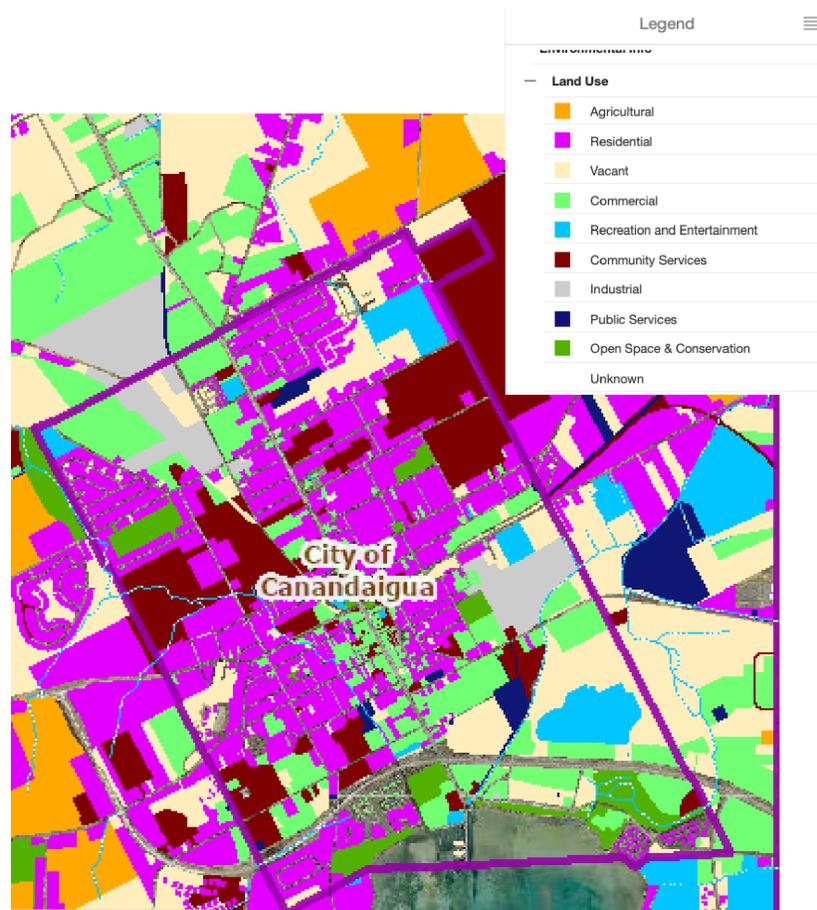
MAP LC1: Land Cover, developed with Ontario County GIS on September, 14th, 2021

recreation, and community services. The majority of land cover in the city is made up of residential, industrial, and commercial infrastructure.

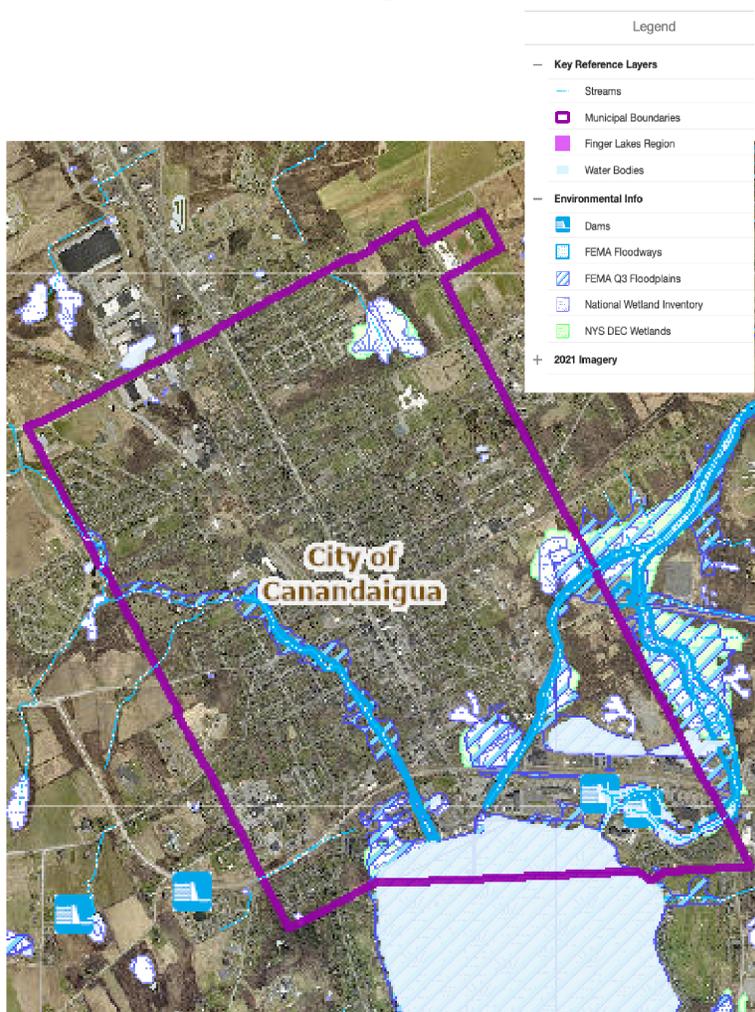
MAP LC2: Open Water and Wetlands, developed with Ontario County GIS on September, 14th, 2021

Open water includes Canandaigua Lake, floodways, and floodplains. There are two dams in the southeast region of the city that regulate the flow of water from the lake and its tributaries. The FEMA floodplains surround tributaries, Canandaigua Lake, and wetlands.

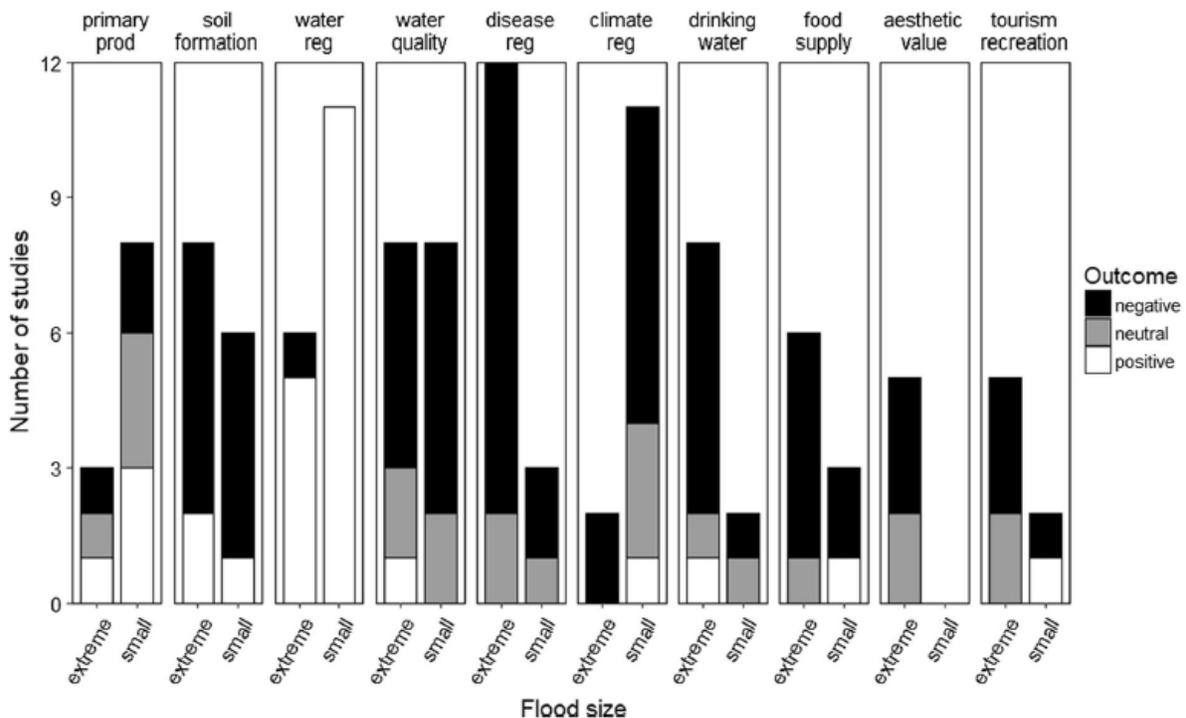
FIGURE WR3: Threats caused by Flooding Figure, 2018, pp 441

Figure WR3 (2018) looks at both extreme and small flooding studies to identify the negative and positive outcomes to each category shown. The top threats (identified as negative outcomes) caused by flooding are climate regulation, water quality, soil formation, drinking water, food supply, and disease regulation. In the 2018 study³⁷, Talbot et al. describe the results of each threat in further detail:

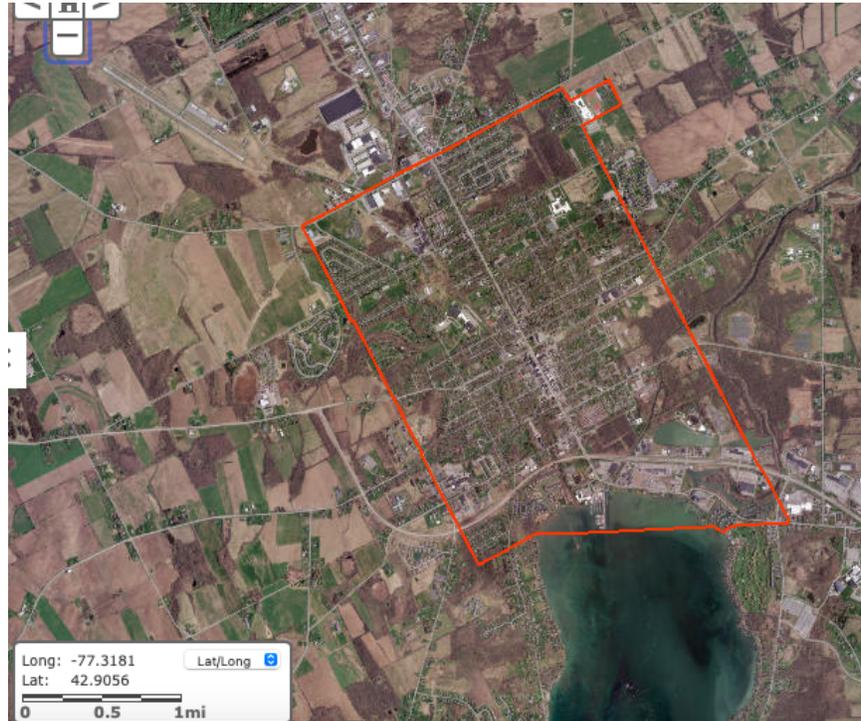
MAP UCF1: Developed with: Discover GIS Data NY, September 5th, 2021

The topographic map (MAP UCF1) developed through Discover GIS Data NY, shows the City of Canandaigua land cover. The city land cover consists of trees and shrubs, grassland, water, impervious roads, impervious buildings, impervious others, and soil.

Within the city boundary, approximately 35% is covered by trees and shrubs. It is important to note that Atwater Meadows Park is 18 acres of uninterrupted forestland and Lagoona Park is a 34 acre nature preserve of mostly wetlands⁴¹. In that case, the tree coverage may be increased due to a higher volume of trees in both parks.

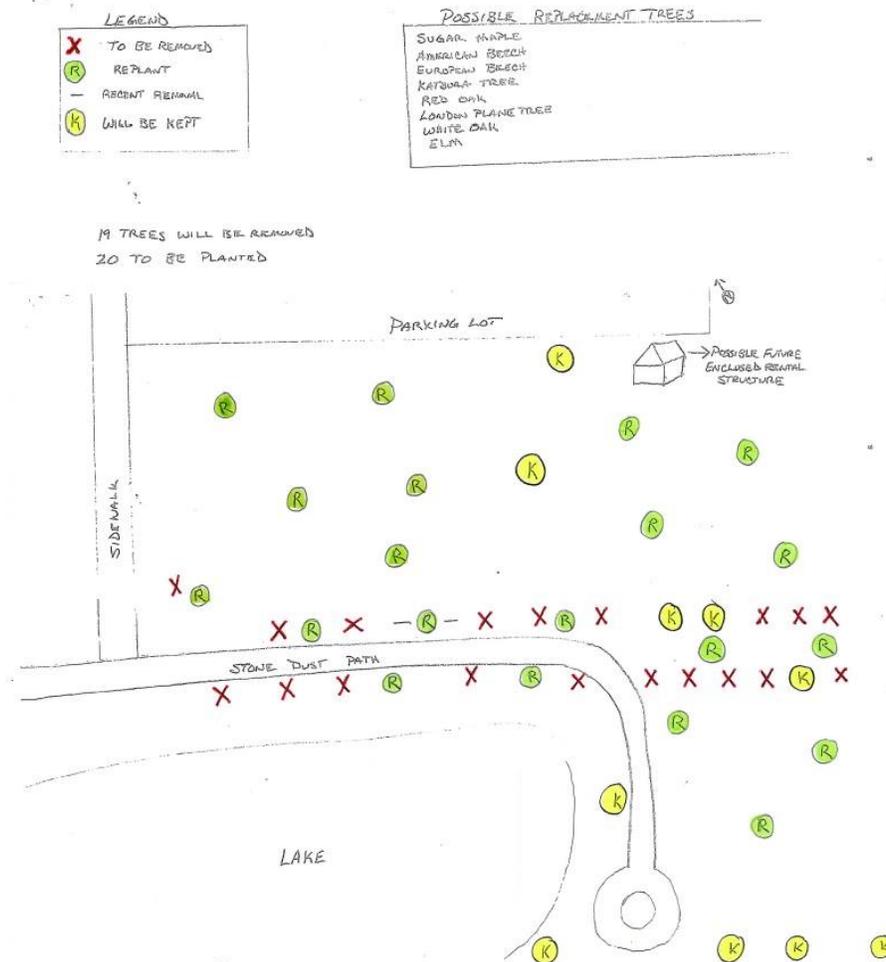
IMAGE UCF1: Lakefront Park Plan, 2015, [index.asp](#)

The Tree Advisory Board selected 19 trees that needed to be removed. The hand drawn image of the park (IMAGE UCF1) marks the location of removal with red x's.. There are 10 trees that will remain and 20 new trees will be planted. For the purpose of diversifying, the Board lists 8 possible tree varieties that will replace the willows. They are as follows, Sugar Maple, American Beech, European Beech, Katsura tree, Red Oak, White Oak, London Plane tree, and the elm.

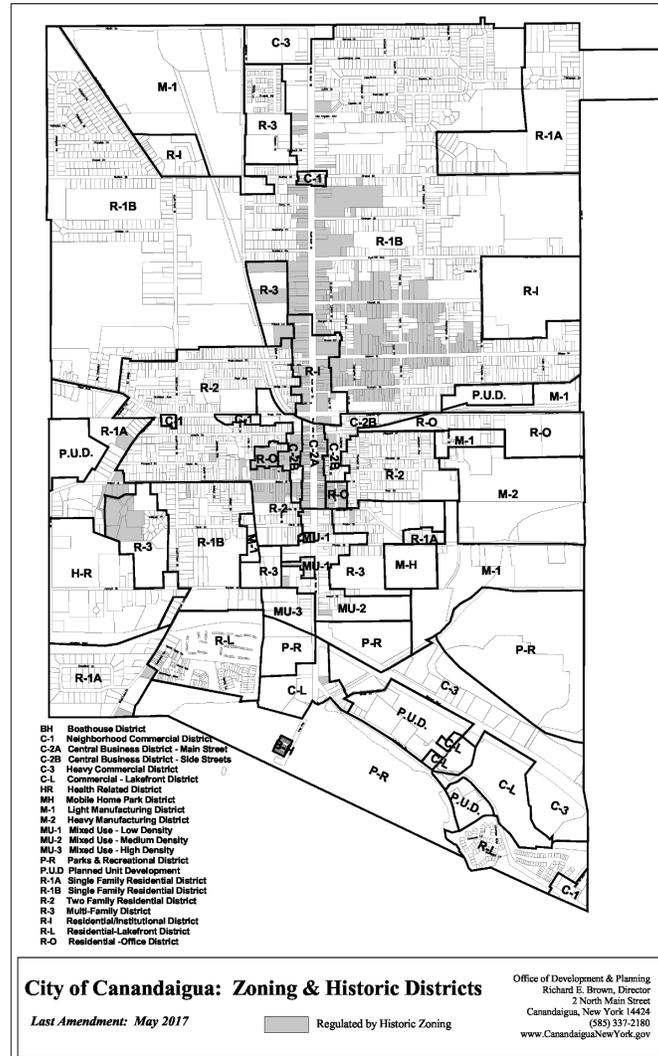
MAP LU1: 2017, Zoning Map⁷⁴

The City of Canandaigua last updated their zoning map in May 2017 (see Map LU1). The map is parceled out by district and density zones. The main categories are parks and recreation, residential, commercial, manufacturing, and mixed-use. Most districts in the city are residential, particularly in the north end. The south end of the city is made up of commercial and business districts, parks and recreation, and a few residential.

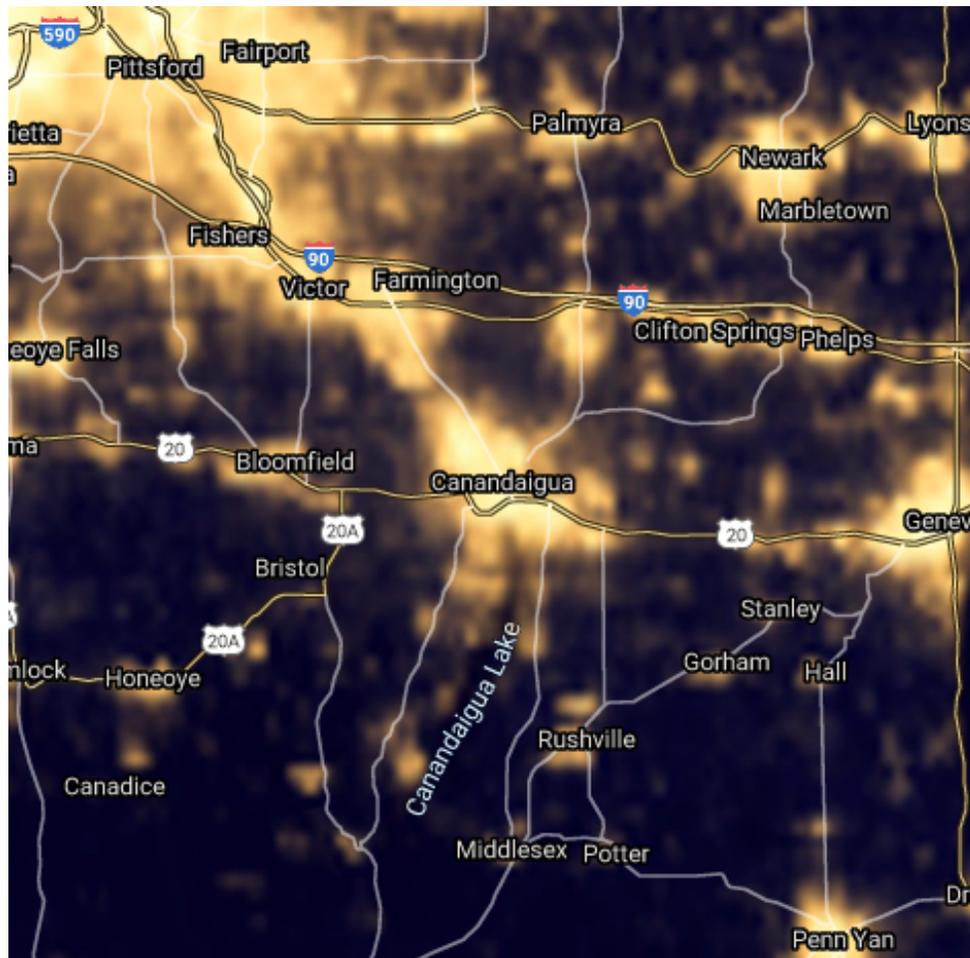
MAP DS1: NASA Blue Marble Navigator, 2012

The Interactive map from NASA uses google to display a top view of the earth's night sky. The map includes city and town lights visible at night. Although the image is not clear in resolution, it is clear to see that the City of Canandaigua has plenty of light pollution, similar to Geneva and Pittsford's light pollution.
